Orakei Basin Management Plan

This document is a management plan for the Orakei Basin and surrounding public open space. It provides direction for the future development, management and use of this open space network.

August 2010

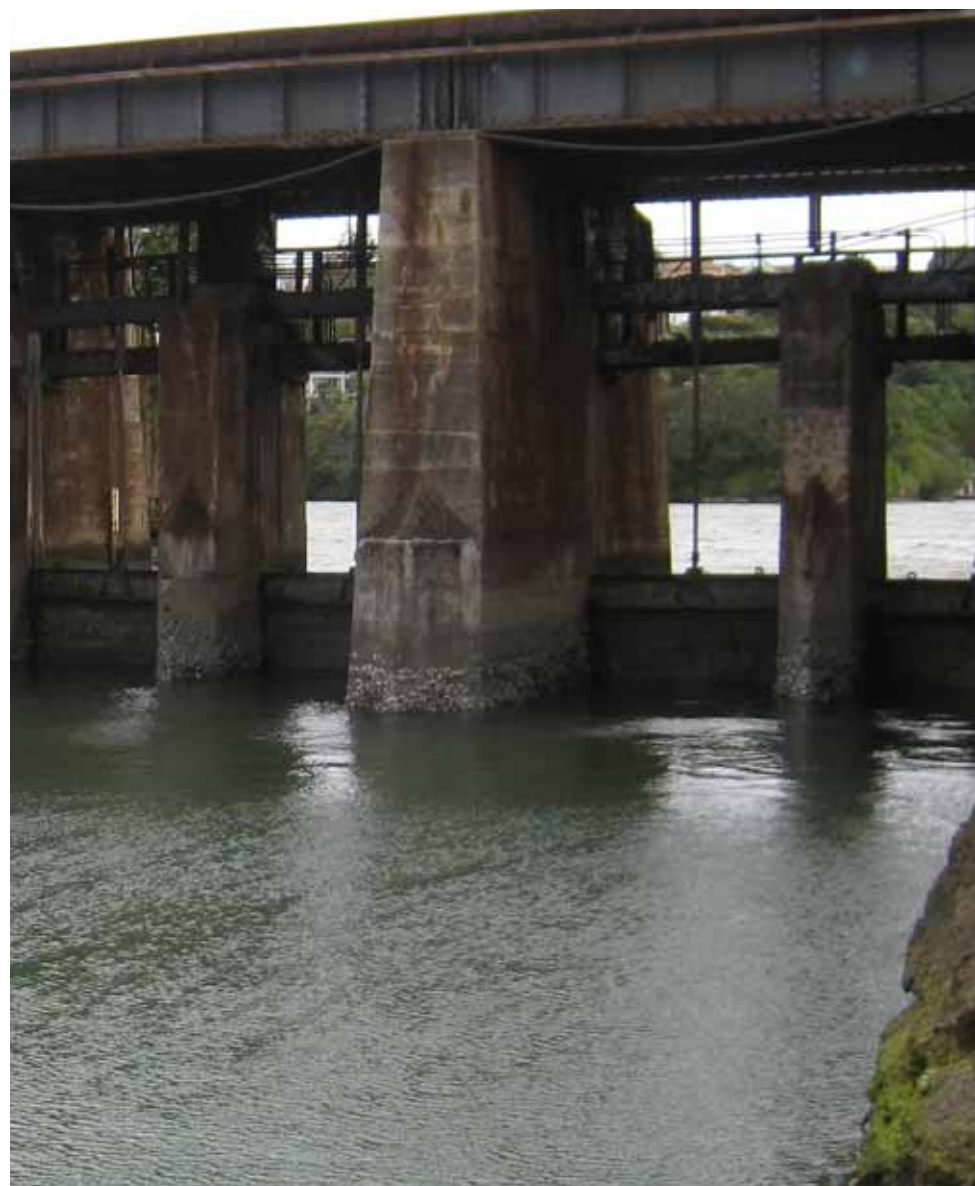
Sluice gates: circa 2008

The sluice gates that impound water in the Orakei Basin leak. This reduces the water level over time. Due to the shallow depth of the Orakei Basin, any drop in water level impacts on the usability of the Orakei Basin for recreation. The drop in water level also exposes increasing areas of mud flats in the upper arms of the Orakei Creek, which would normally be covered in water, affecting amenity values.

In 2010 the sluice gates will be upgraded to reduce leaking and improve performance. The improved gates should achieve better water retention within the basin, and will continue to provide for water impoundment. In recent times, the Auckland Water Ski Club (AWSC) has operated the sluice gates.

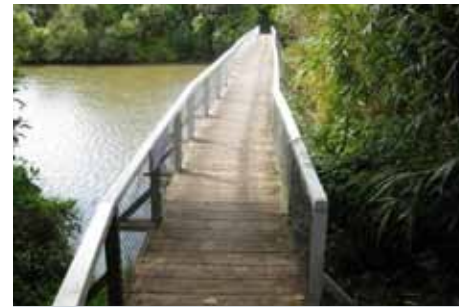
Pedestrian footbridge over eastern arm of Orakei Creek, from Waiatarua Road

The Waiatarua Road part of the walkway is a moderately sloped asphalt path with a white painted wooden handrail that is similar in style to the footbridge. The entrance to the walkway is not readily apparent from the street and is not marked by signage. The reserve is 600m² in area, slopes relatively steeply down to the water edge, and contains a variety of maturing vegetation including native and exotic species. Just to the west of the base of the footbridge, where the land slopes to the water, is steep informal track that leads to a small, roughly constructed concrete landing at the water edge.

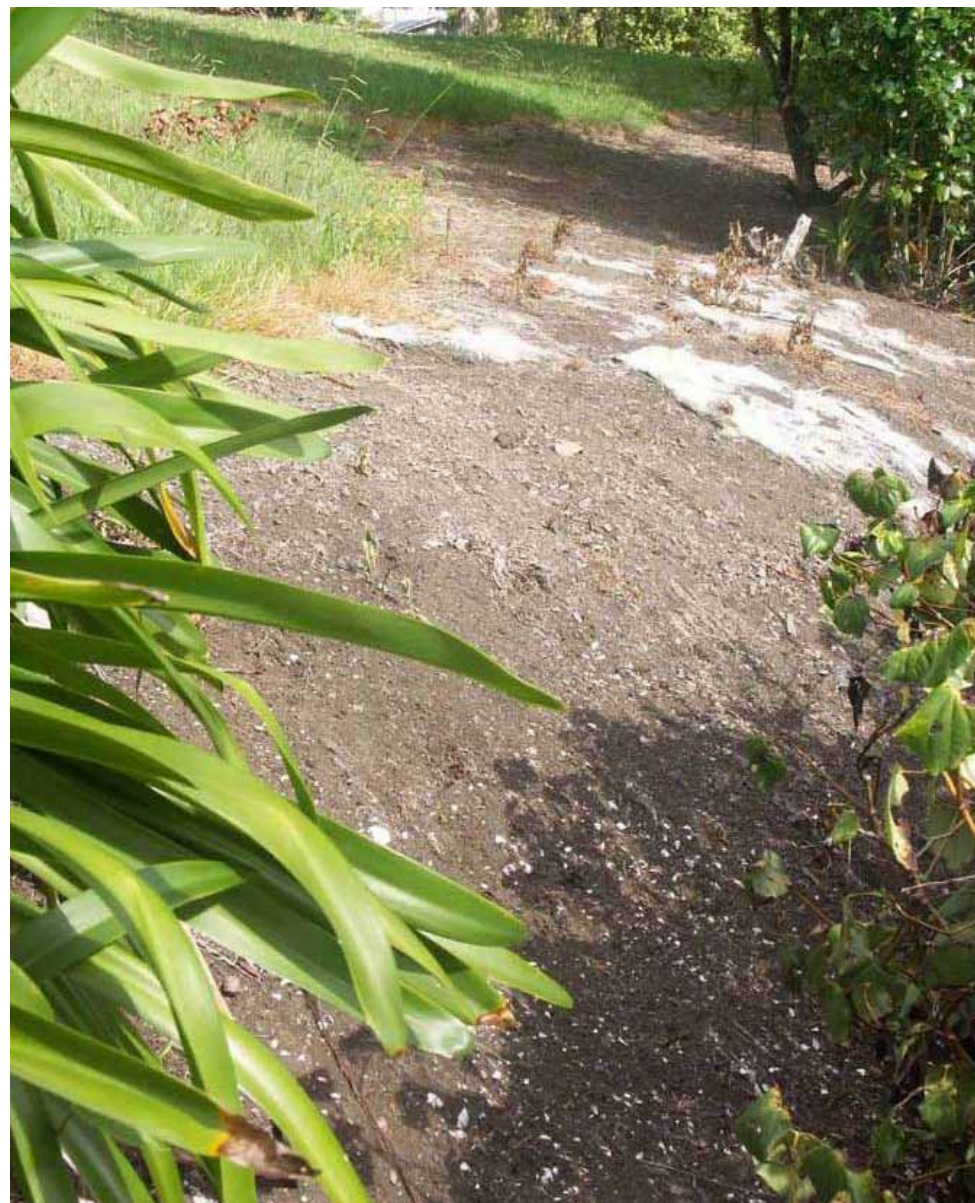
Kelvin Reserve Midden (R11/1765) – R. Foster 2010

Archaeological sites are particularly at risk from erosion, public access and vegetation management include the pa at the Orakei West Reserve and the midden site in the Kelvin Reserve. Evidence of erosion is present at both sites R11/87(Pa) and R11/1765 (Kelvin Reserve).
