19 Archaeological survey

Orakei Basin
Management – Issues
and Actions Report by
Andrew.Stewart Ltd

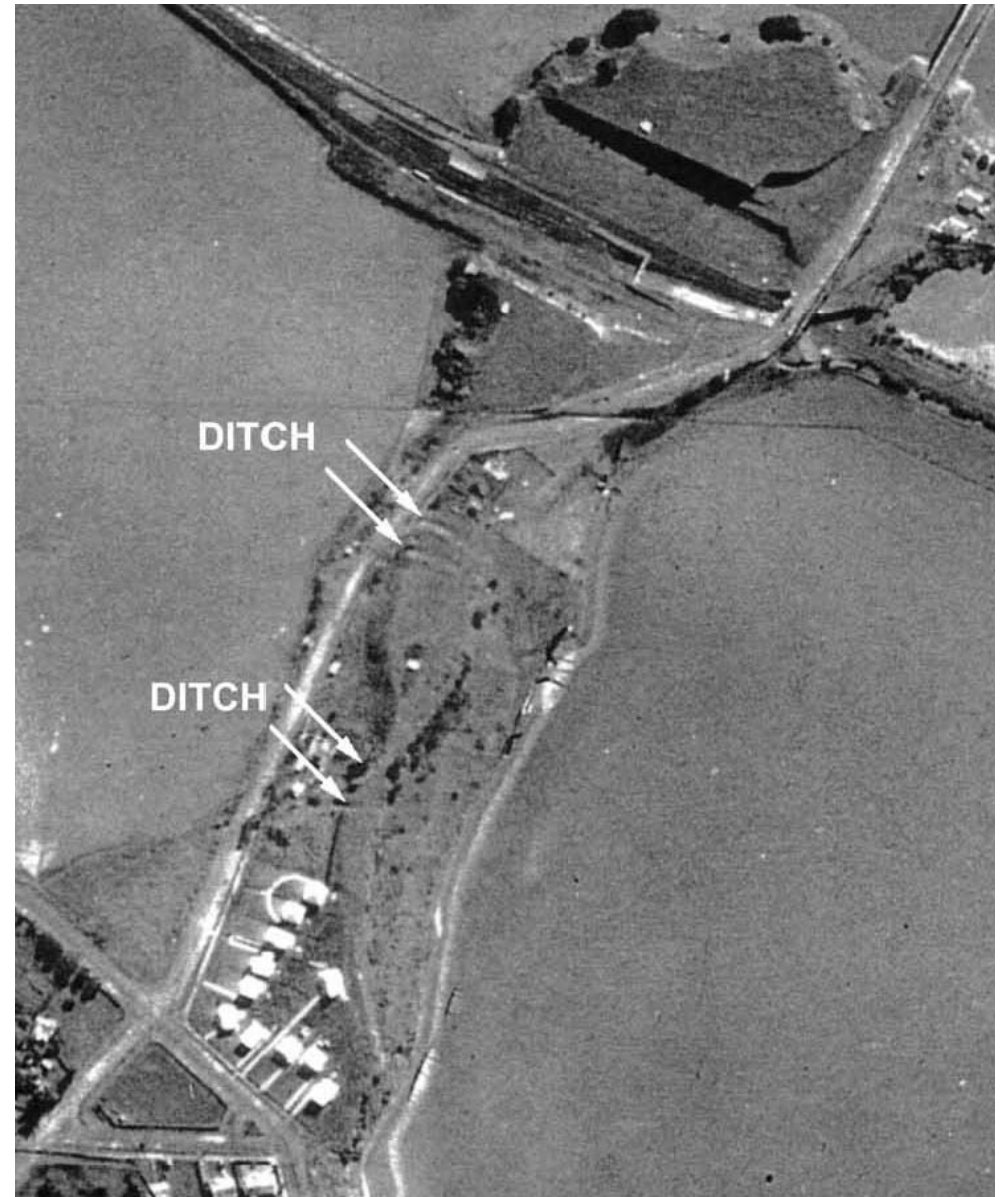
R11/87 is the Orakei Pa, a ridge pa occupying the ridge top (and sides) between Hobson Bay and the Orakei Basin. The basic extent of the pa can be seen in Figure 10, the 1940 aerial photograph, which shows where the defensive ditches were present. There are also terraces on either side of the ridge on the slopes leading down to the basin and to Hobson Bay, the latter cut by Orakei Road. Investigations undertaken by Best (2002) and Tatton and Clough (2005) also found occupation evidence outside the defences along the ridge top to the north and south of the pa.

Figure 10: 1940's aerial photograph showing Orakei Pa (R11/87?)

In his 2002 report Best (2002: Figure 8, reproduced here as Figure 11) shows the ditch locations he identified during his investigations, two at the southern end and a small portion of one towards the northern end. The ends one of the southern ditches are still visible but the northern ditches have been completely filled and cannot be easily identified on the ground. Best (2002: 13) includes a photograph from a 1967 University of Auckland excavation at the site. The photograph shows a cross-section of a ditch in the Orakei Road cutting. This is marked in Best’s Figure 8, and it does seem to correspond with the location of one of the two northern ditches in the 1940 aerial.

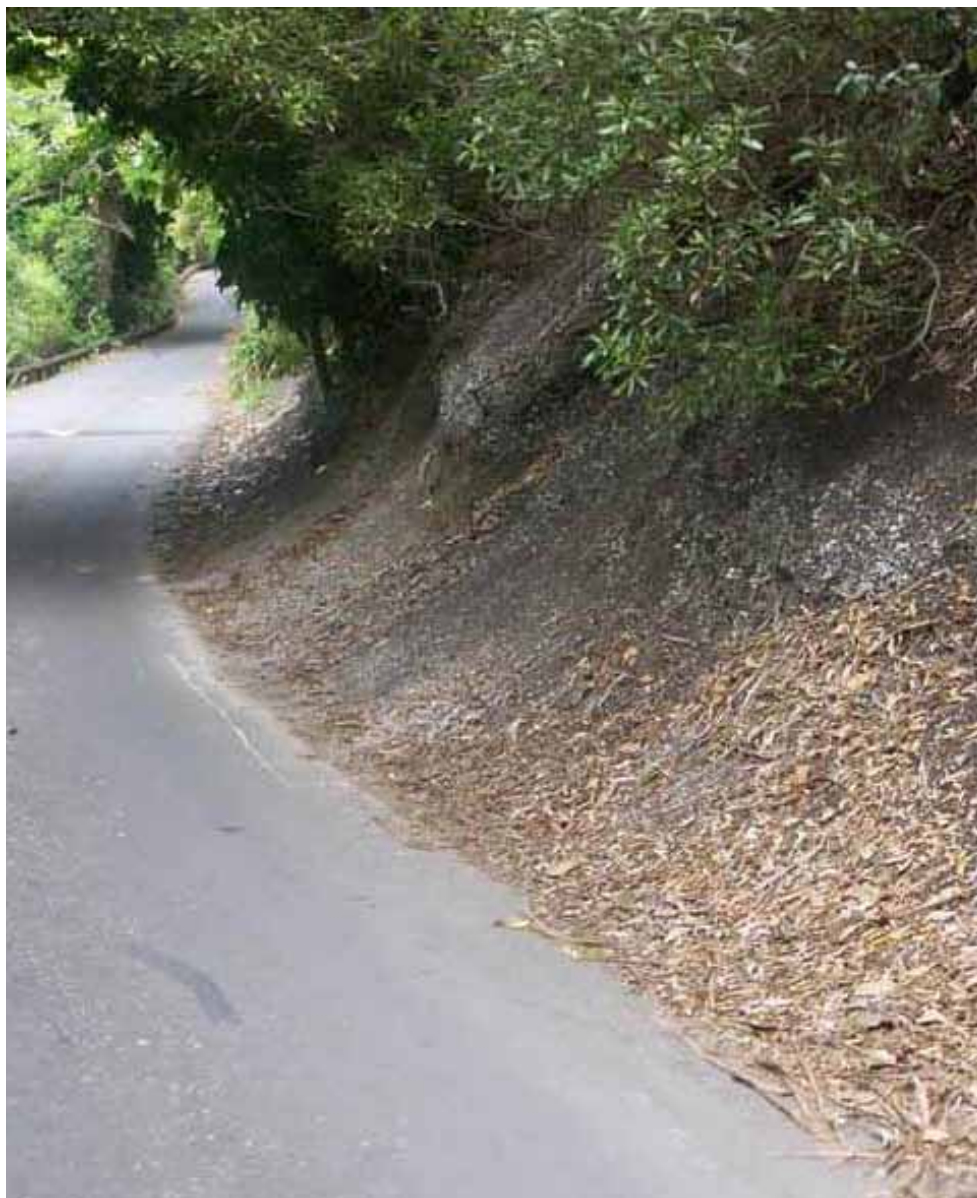
Orakei Basin West Reserve access road midden (R11/87) – R. Foster 2010

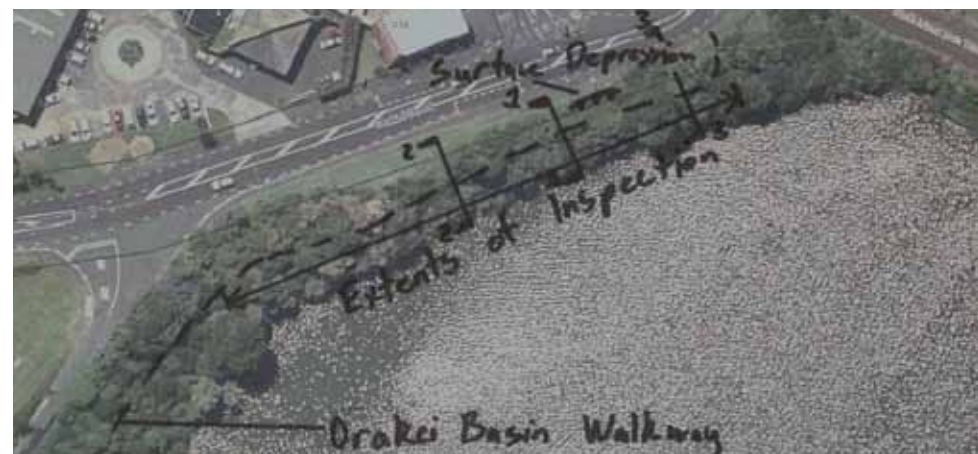
"... we conclude that the risk of future instability is subjectively assessed to be low for the slopes in general, but with a possibly increased risk of future instability associated with a surface depression identified at the top of the slope. As noted above, ongoing fretting and erosion of the over steepened cut slope immediately up-slope of the walkway is expected to continue but the probability of a larger scale slip is subjectively assessed as low. Should such fretting and erosion be of concern then installation of a retaining wall over that over-steepened section, ie up to the level of the root layer, could be considered."

Source: Tonkin & Taylor 1 August 2008 Orakei Basin Visual Assessment of Slope Stability
