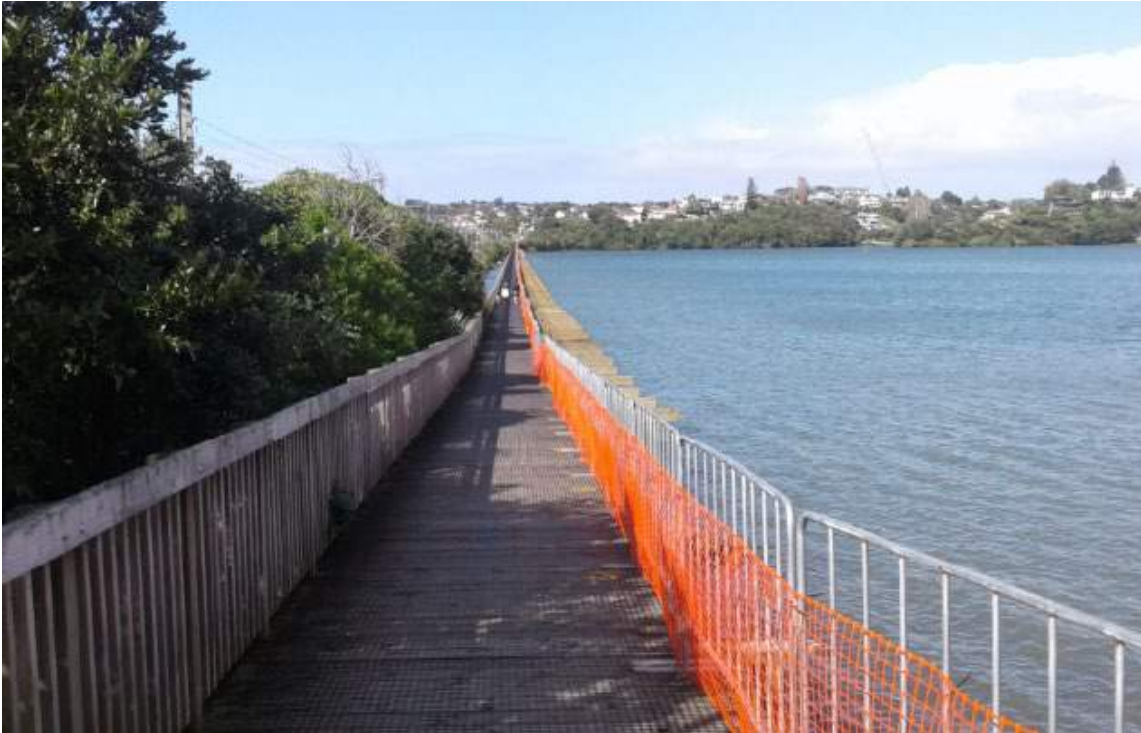
The existing boardwalk along the railway embankment across the Basin is in the process of being widened by NZTA as a key link in the Glen Innes to Tamaki Drive shared pathway.

Figure 17: Upgrade works on the railway embankment boardwalk across Ōrākei Basin

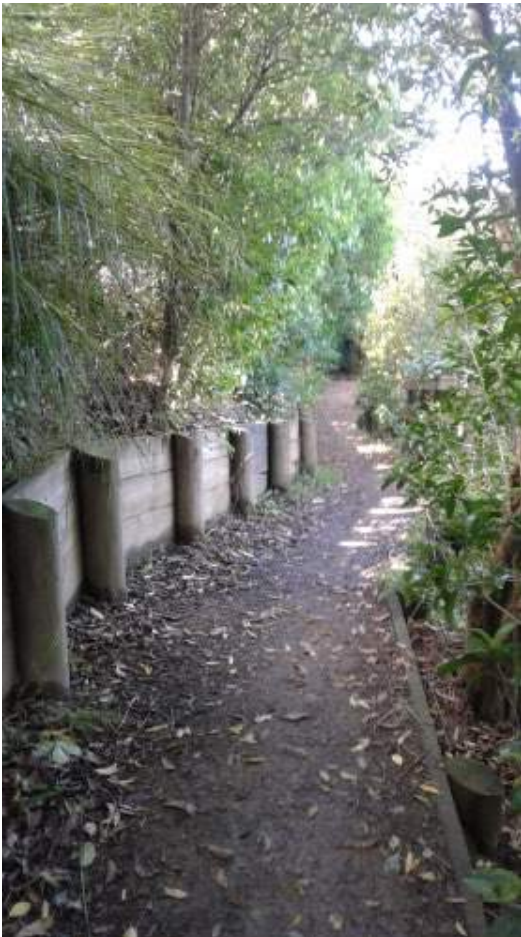
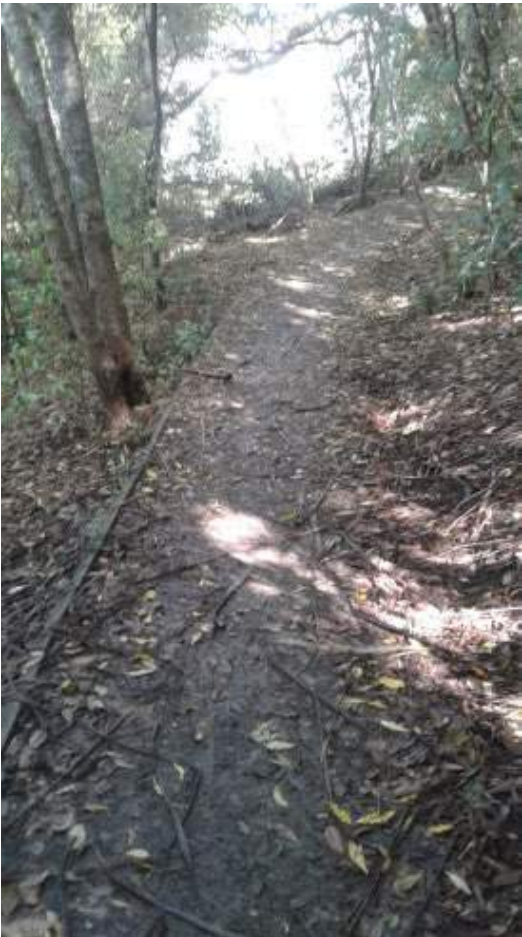
Figure 19: Examples of the lower aggregate track below Ōrākei Road

- Further upgrade work could be undertaken on sections of bush track below Ōrākei Road and through Macpherson Street Reserve to provide a higher standard of aggregate walking track, which will provide a more consistent surface suitable for all abilities.

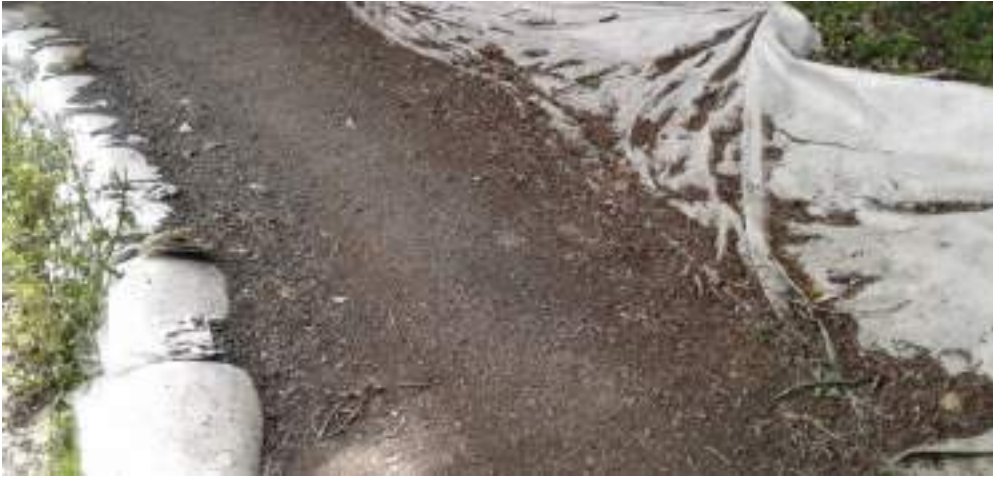
The renewal of the path around the Ōrākei Basin West and East reserves is currently underway. This will provide a wider and more consistent walking surface through this southern section of the Basin walkway.

Figure 21: Temporary path remedial work in Ōrākei Basin East, awaiting the upgrade project

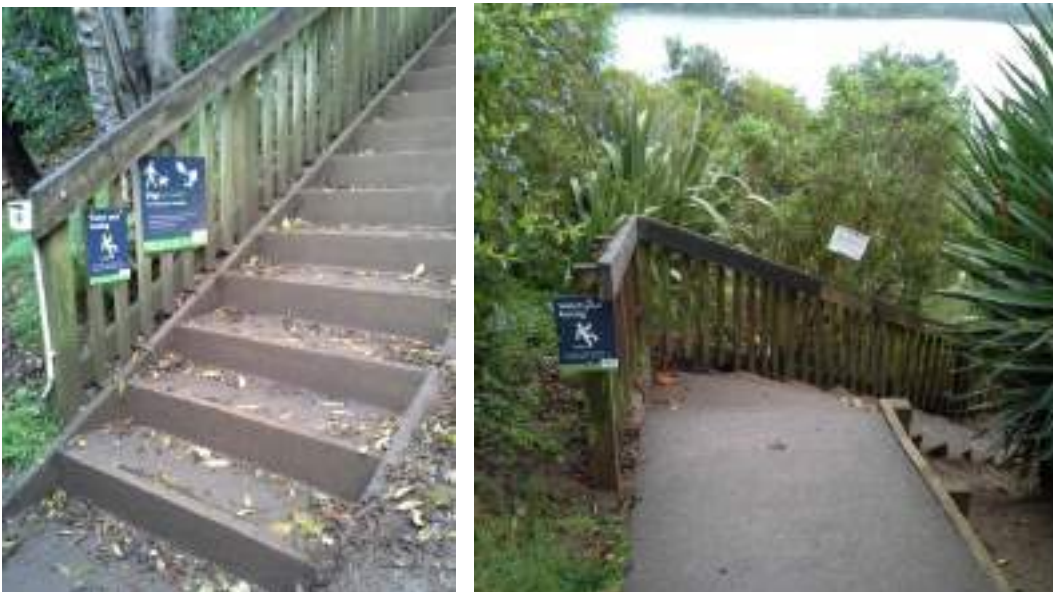
The existing terrain of the Ōrākei Basin open space network makes providing an all access path network in all places unachievable. The existing steps at the Auckland Water Ski Club up to Lucerne Road, steps from Lucerne Road down to the footbridge across Ōrākei Creek, and steps from Ōrākei Road down to the bush track, all prohibit the entire walkway being fully accessible for all users.

Figure 22: Examples of the difficulty in achieving universal access in all locations of the path network

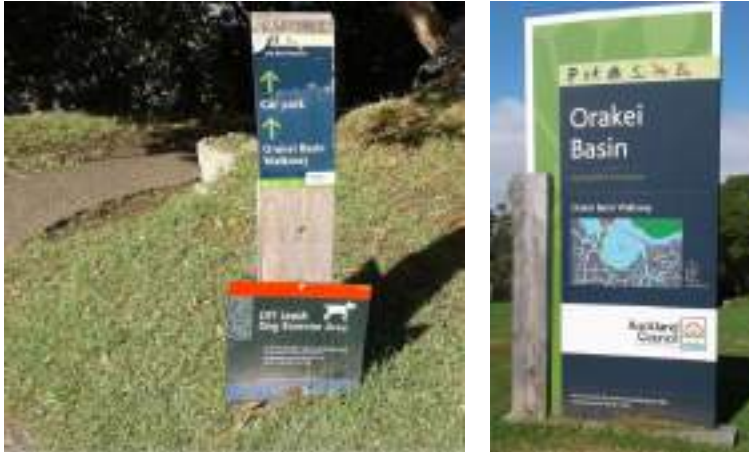
Figure 23: Way finding signage

However directional signage is available at several entrance points to the walkway around the Basin. This provides a basic level of way finding for walkway users.

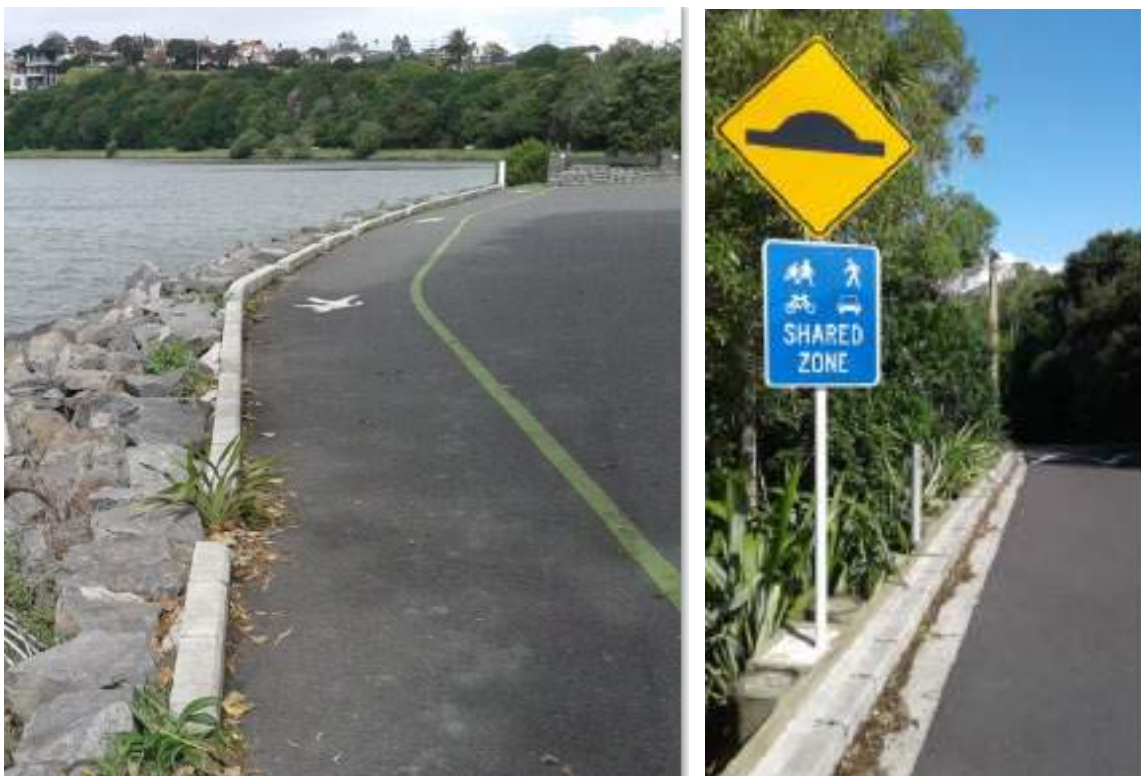
Figure 24: Pedestrian movement through shared spaces

A delineated pedestrian area through the main car park is marked on the pavement to provide a legible access route through this section of the walkway. Signage indicates the access road is a shared zone for pedestrians, cycles and vehicles.

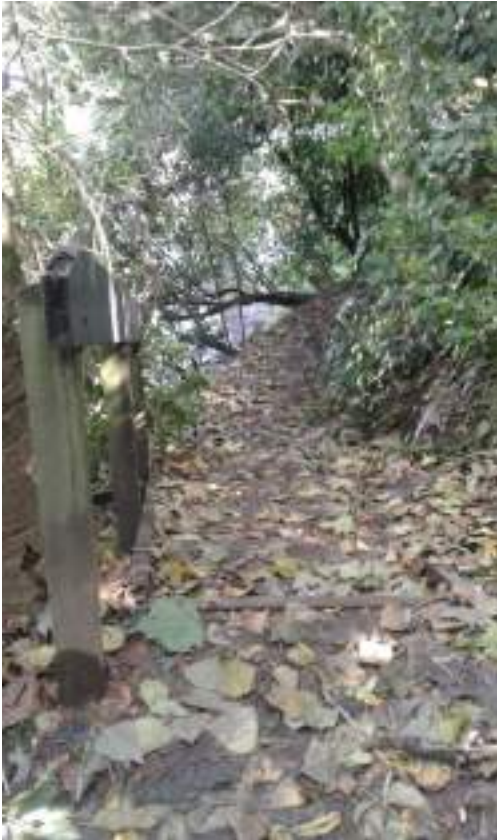
Figure 25: Steps below Ōrākei Road

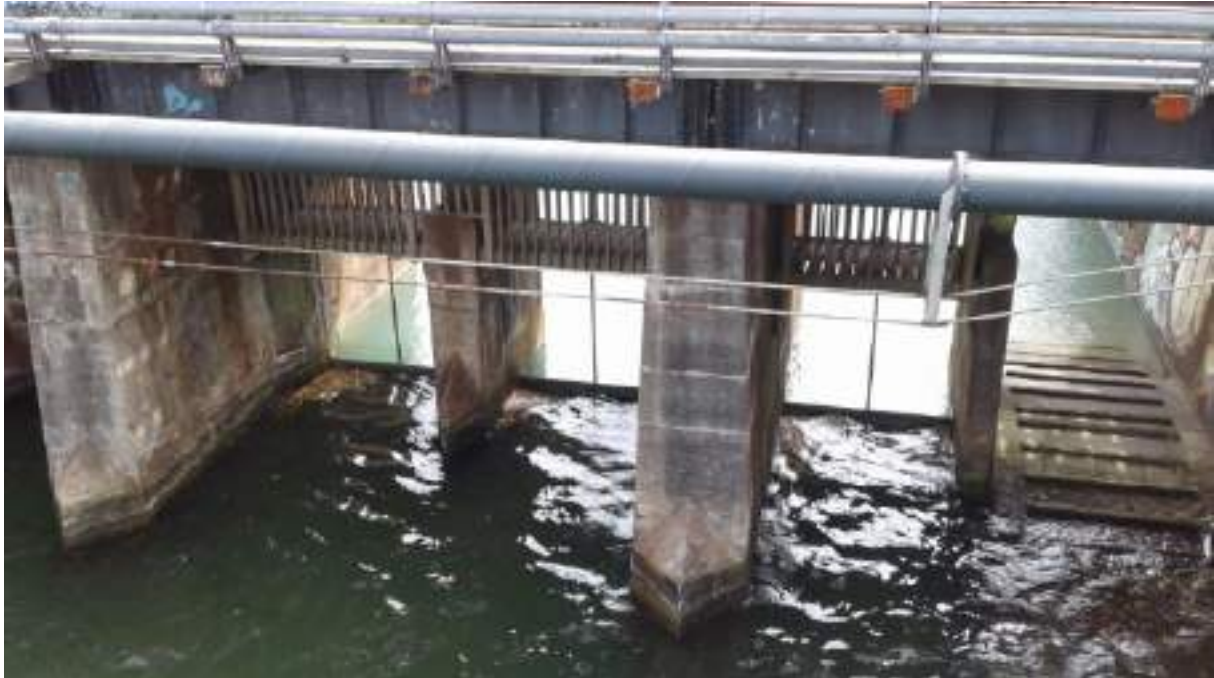
The sluice gates were upgraded in 2010 due to the previous gates leaking, resulting in a gradual lowering over time of the water level impounded in the Basin. The operation of the gates for flushing of the Basin has continued to remain with the Auckland Water Ski Club to manage. Operation of the gates is undertaken by club members manually opening and closing the gates by a control box over the sluice gates. The performance standards for the operation of the gates are:

Figure 26: Sluice gates programmed for upgrade to an automated operation

A project is included in the Ōrākei Local Board's forward renewal programme for the gates to be automated and operation of the system to revert back to Auckland Council. The automation project will enable the water levels of the Basin to be monitored via alarms and cameras, with the functionality of controlling the gates remotely.

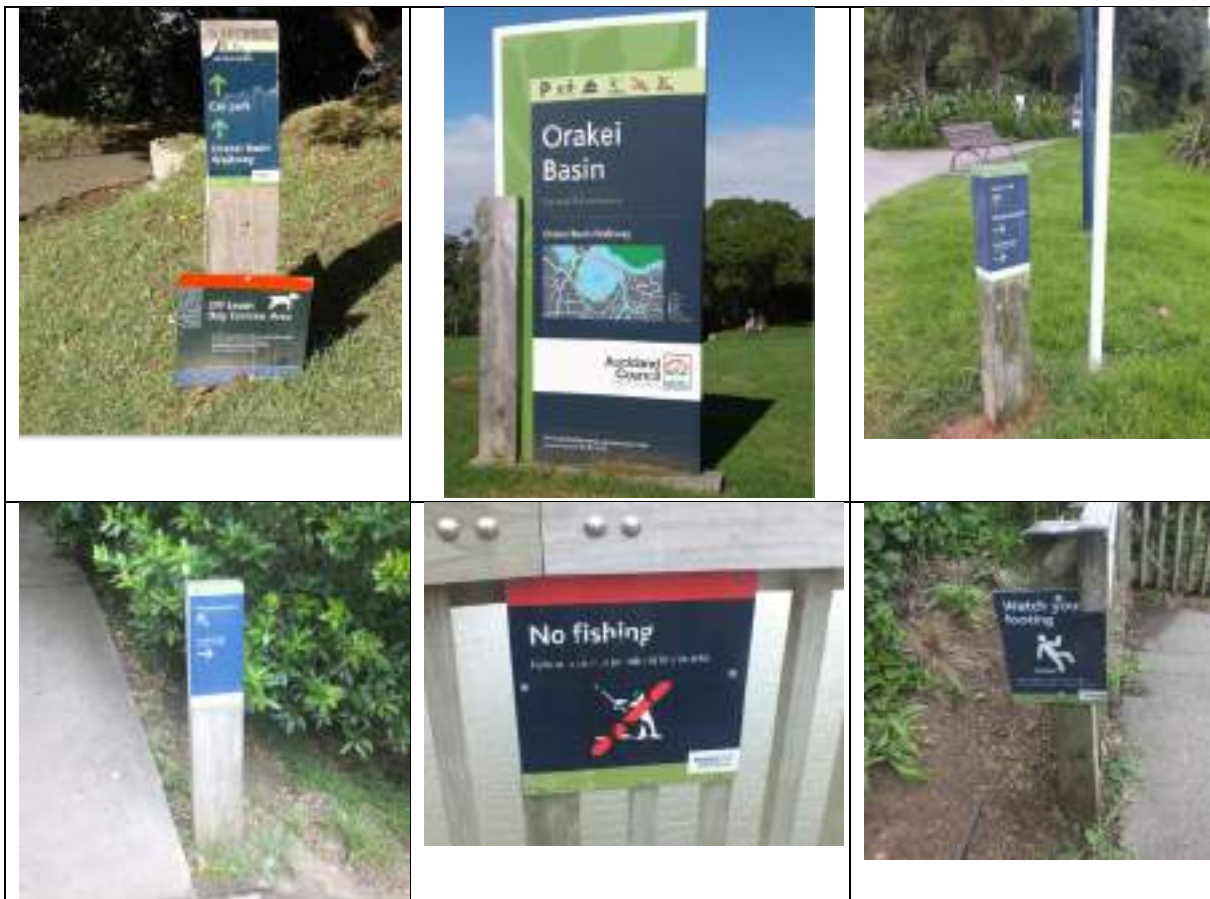
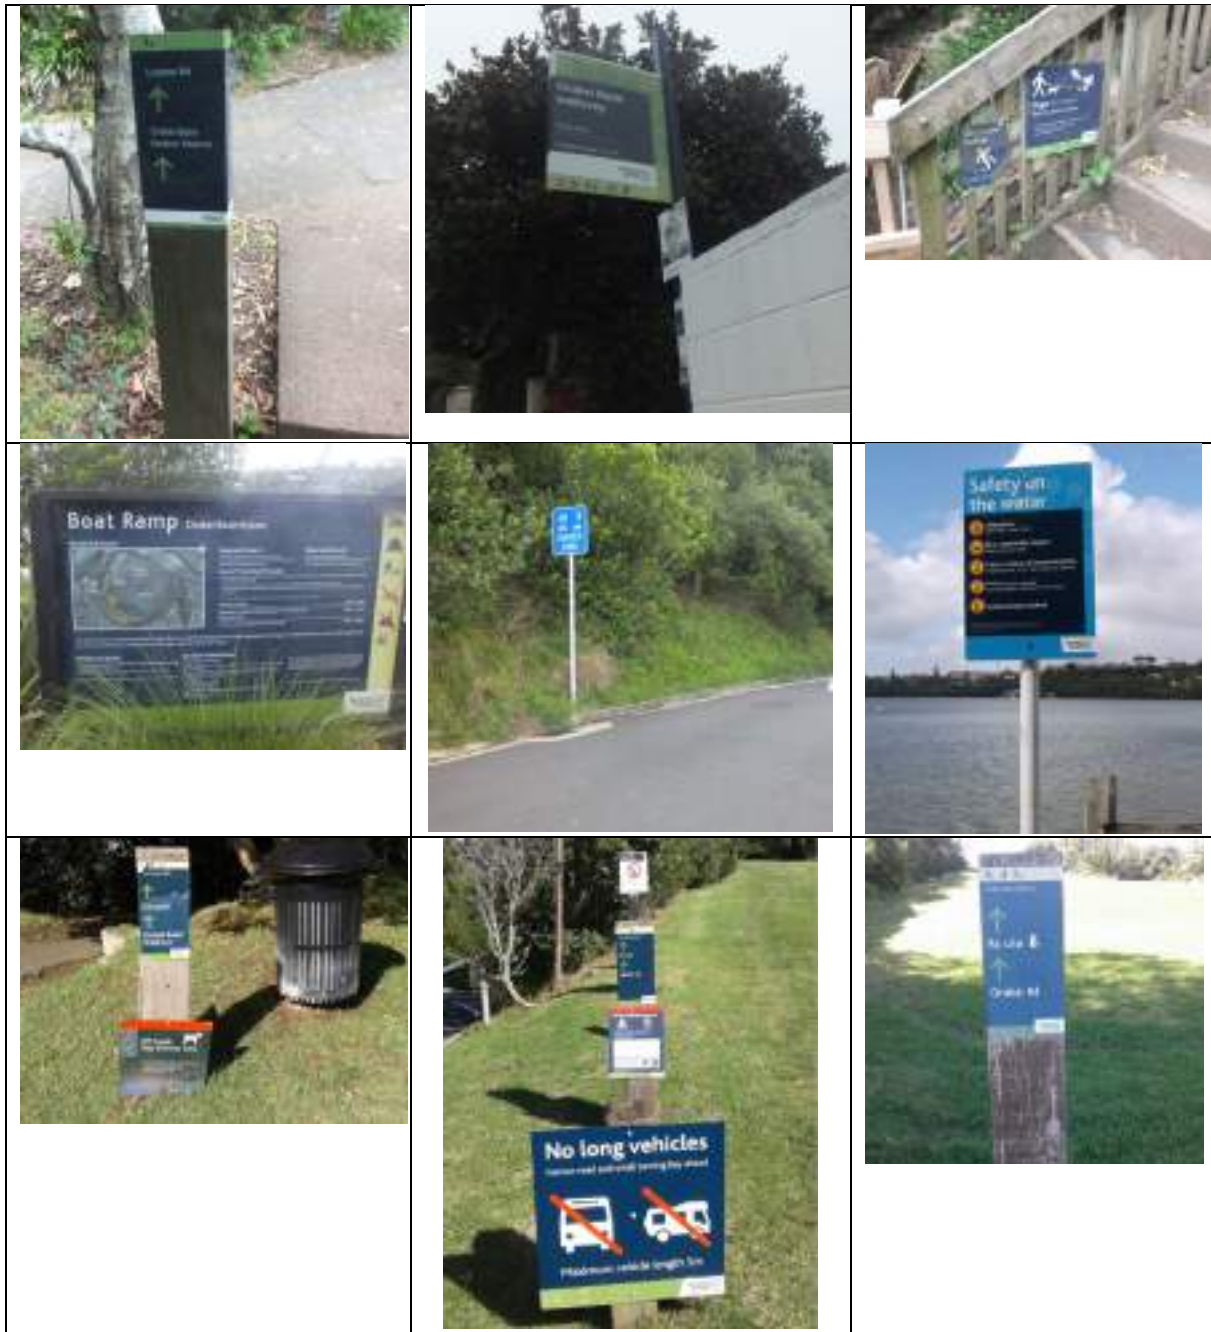
A signage project was completed in 2013 to achieve a consistent style of signage in line with Auckland Council standards. The signage has been predominantly installed at entrances and high use locations around the Basin. Examples included below illustrate that the signage installed around the Basin is for the purpose of identification, way finding, safety, dog off-leash areas, and water bylaw regulations. Replacement, cleaning, and vegetation trimming around signs is required in places.

Figure 29: Examples of signage installed around Ōrākei Basin

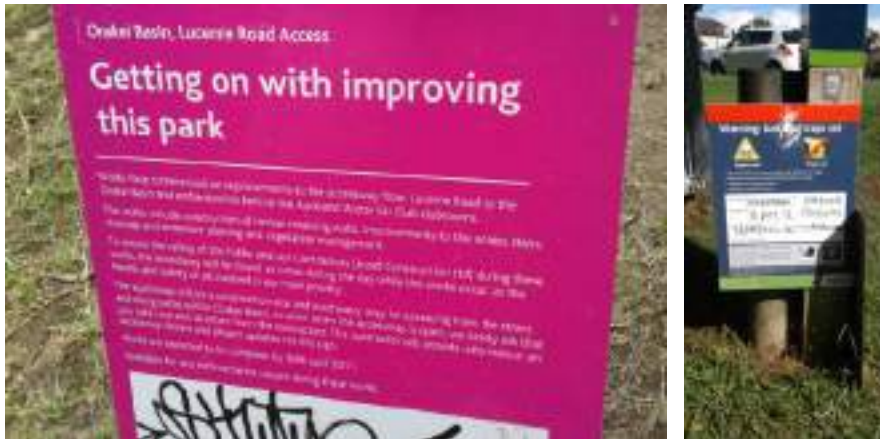
Figure 30: Temporary project works and pest control signage

Other temporary signage is installed in locations related to specific project work for physical works improvements and pest control. Removal of this signage is necessary after the scheduled event to avoid confusion with park users and to maintain a clutter free environment.

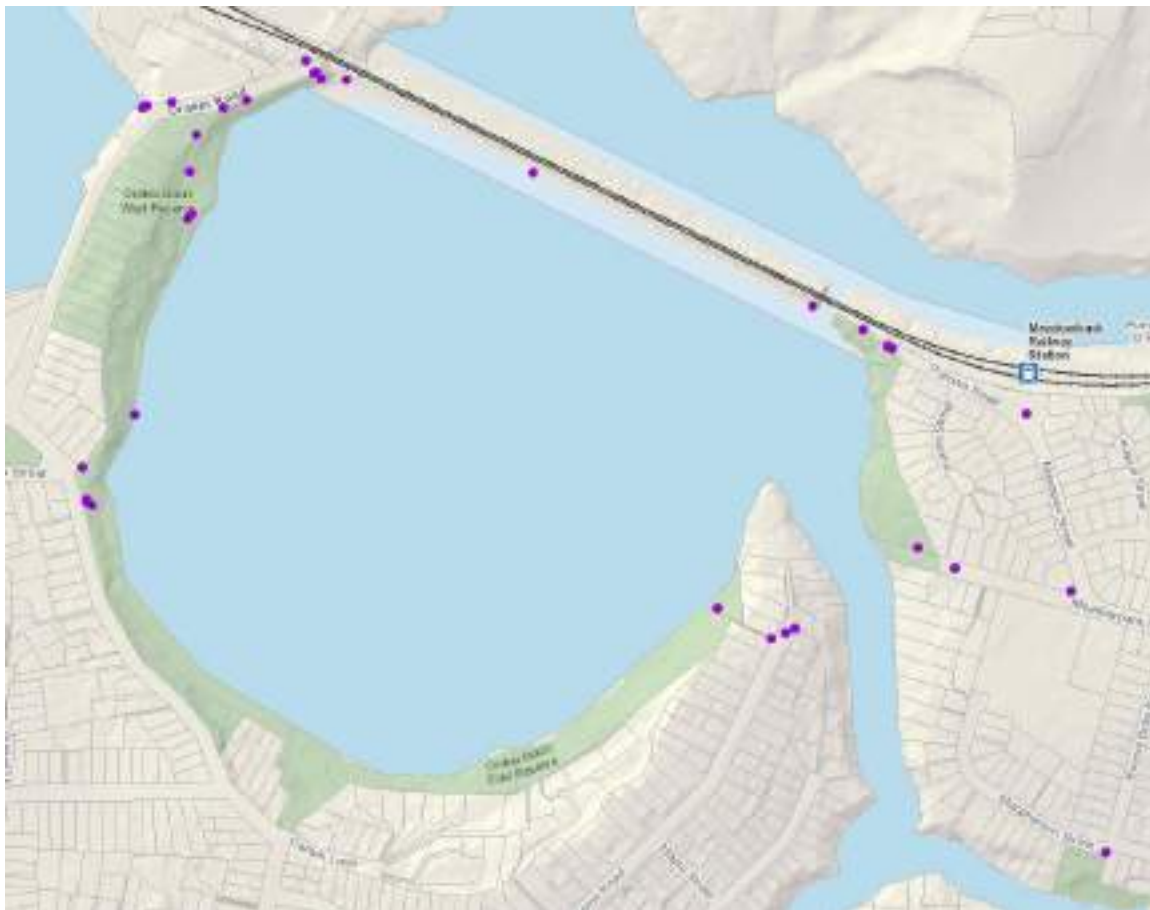
Figure 31: Current mapped locations of signage within the Ōrākei Basin reserves

Locations of signage installed around Ōrākei Basin and adjacent open space areas is indicated below.

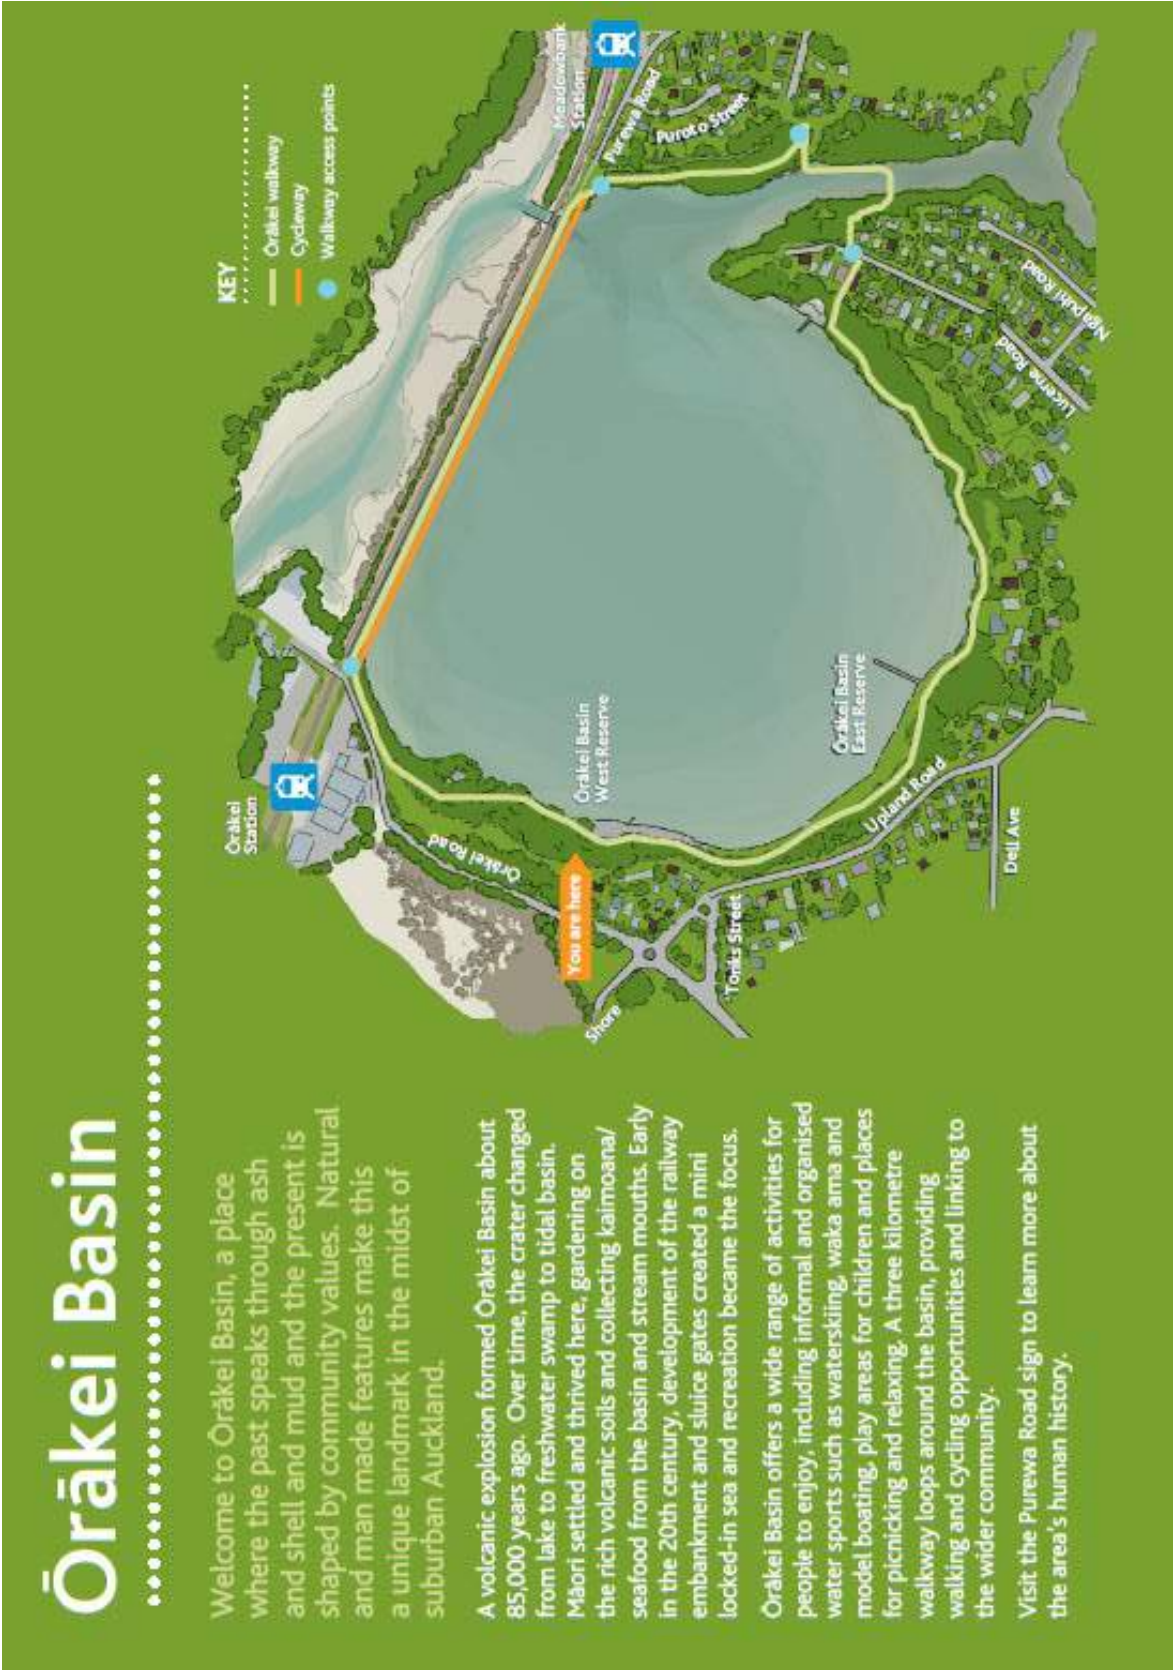
Figure 32: Draft interpretation signage prepared for installation in 2012

Draft interpretation signage was developed in 2012 for placement at the main car park and at the Purewa entrance to Macpherson Street Reserve. The signage provided a natural and cultural history of Ōrākei Basin. Due to the timing of related upgrade works in the vicinity, the signage was not installed. The need for interpretation signage around

the Basin in particular is high, and it is recommended this project be re-activated subject to a review of the draft signage and sufficient budget being available for installation.

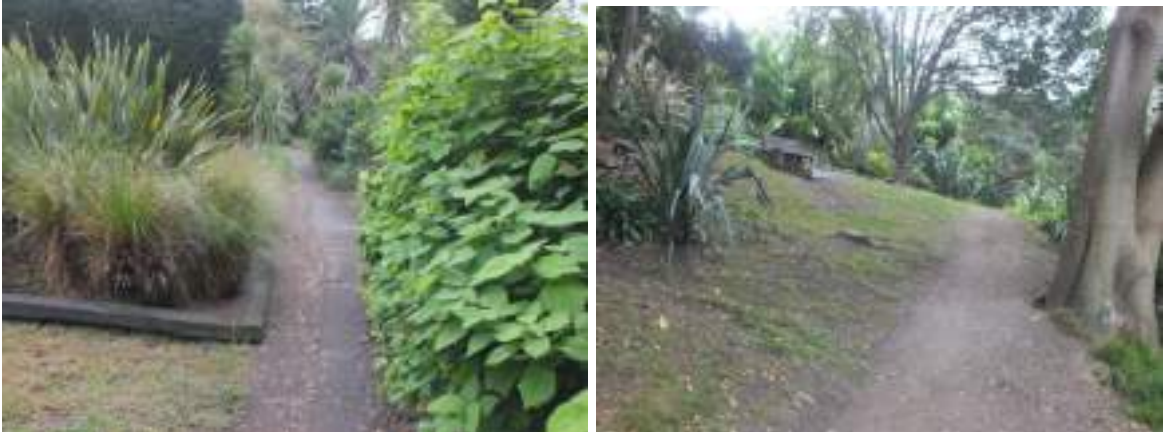
Figure 36: Representative images of encroachment in to the reserve along the walkway loop

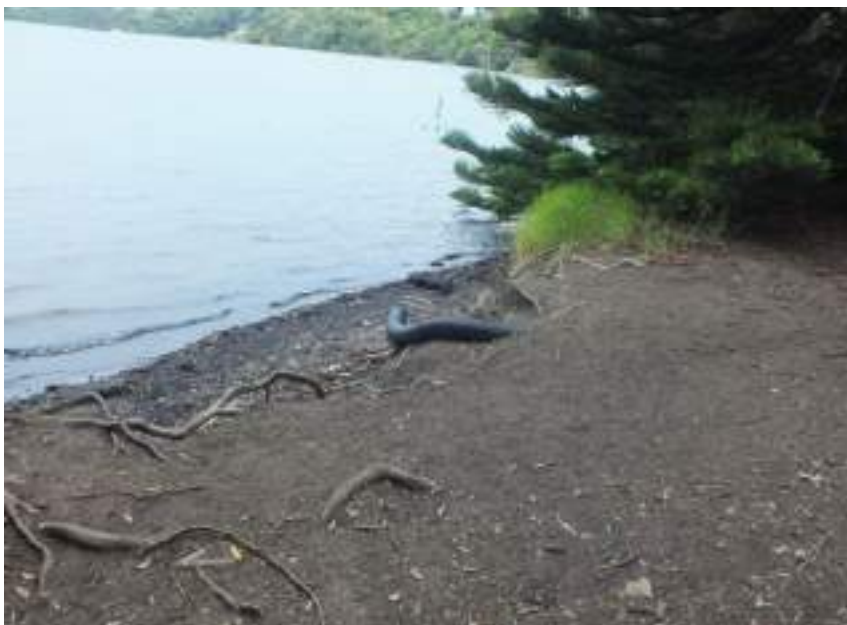
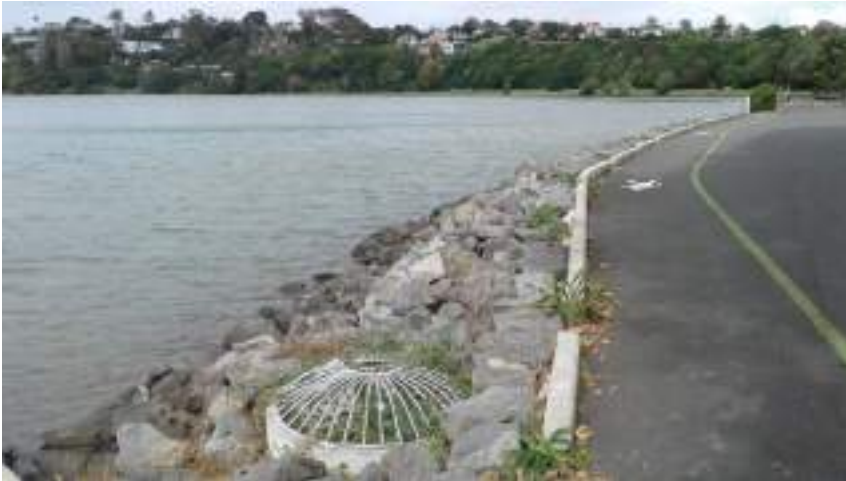
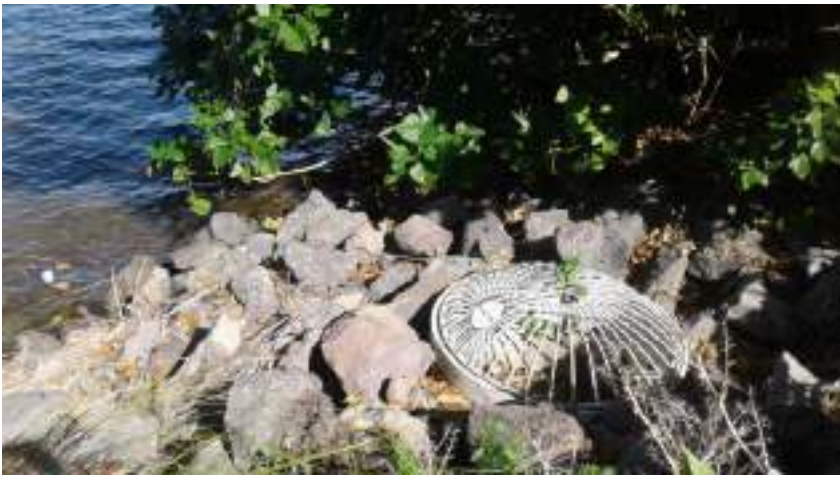
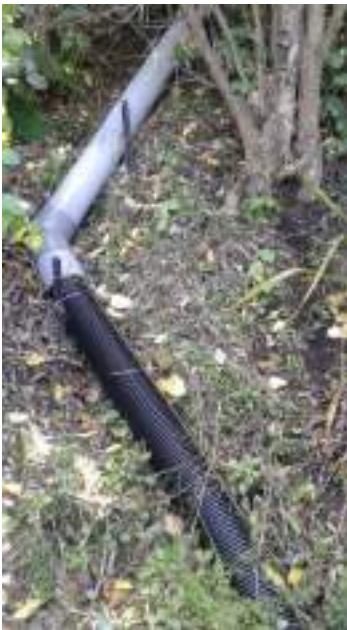
Sinclair Knight Merz completed a stability feasibility study for Council in 2011. The study considered erosion and stability issues affecting the Ōrākei Basin walkway, the access road and car park areas for the boat clubs and general public, and the Basin edges. The report noted that amongst other factors, areas of erosion and poor bank stability were in part being caused by poor stormwater drainage. Poor channelling of runoff and poor outlet erosion control from private and public stormwater outlets were identified as causal factors. The report made a series of recommendations, based on areas listed by priority. The access road from Ōrākei Road to the boat car park, and then along the internal road to the public car park, were identified as immediate areas of focus and remediation. One key recommendation from the report was for rock protection from the outlet of stormwater pipes (both public and private) to the water's edge, to protect against surface erosion and reduce the risk of slips and margin erosion. This could be implemented through an ongoing programme of upgrades. A survey of all stormwater outlets entering the Basin is needed to determine the extent of the protection work required. As can be seen in the photos, some improvements have been made already with soft flume pipes extending the point of discharge of stormwater to the water's edge, with other examples of exposed nova coil pipe requiring rock protection.

The report noted that in places stormwater catch pits had been installed in positions along the walkway to dissipate local ponding, and in general were operating effectively. The walkway design around this section of the shoreline will include the following measures to manage stormwater flows (Morphum Environmental Ltd. 2015):

Figure 37: Examples of storm water discharge points and outlets within the Basin

- planted swales be installed to collect and convey flows on the uphill side of the walkway under the path and to the Basin
- formal overland flow paths to convey large rainfall events from the planted swales to the Basin. Boardwalks are proposed where the overland flow crosses the path
- installing rip rap in locations at the Basin edge that appear to be eroding from tidal action
- rip rap dissipation should be installed downstream of outfalls discharging into the Basin to prevent further incision, which could lead to bank instability.

- In accordance with the recommendations of the SKM 2011 report, undertake a survey to catalogue and map all stormwater discharge points and channels into the Basin, and prepare a programme of upgrades to the discharge point to reduce erosion, flooding, and damage to public assets e.g. rock armouring.
- Update the SKM 2011 report to identify and monitor areas of active erosion and potential erosion on a plan. These should be assessed and classified in accordance with a set risk rating, and mitigation / management measures identified.
