Selwyn Bush - orientation plan

1. Introduction

This document provides practical restoration guidance to the Pourewa Restoration Group and also to other volunteers assisting with the rehabilitation of Selwyn Bush.

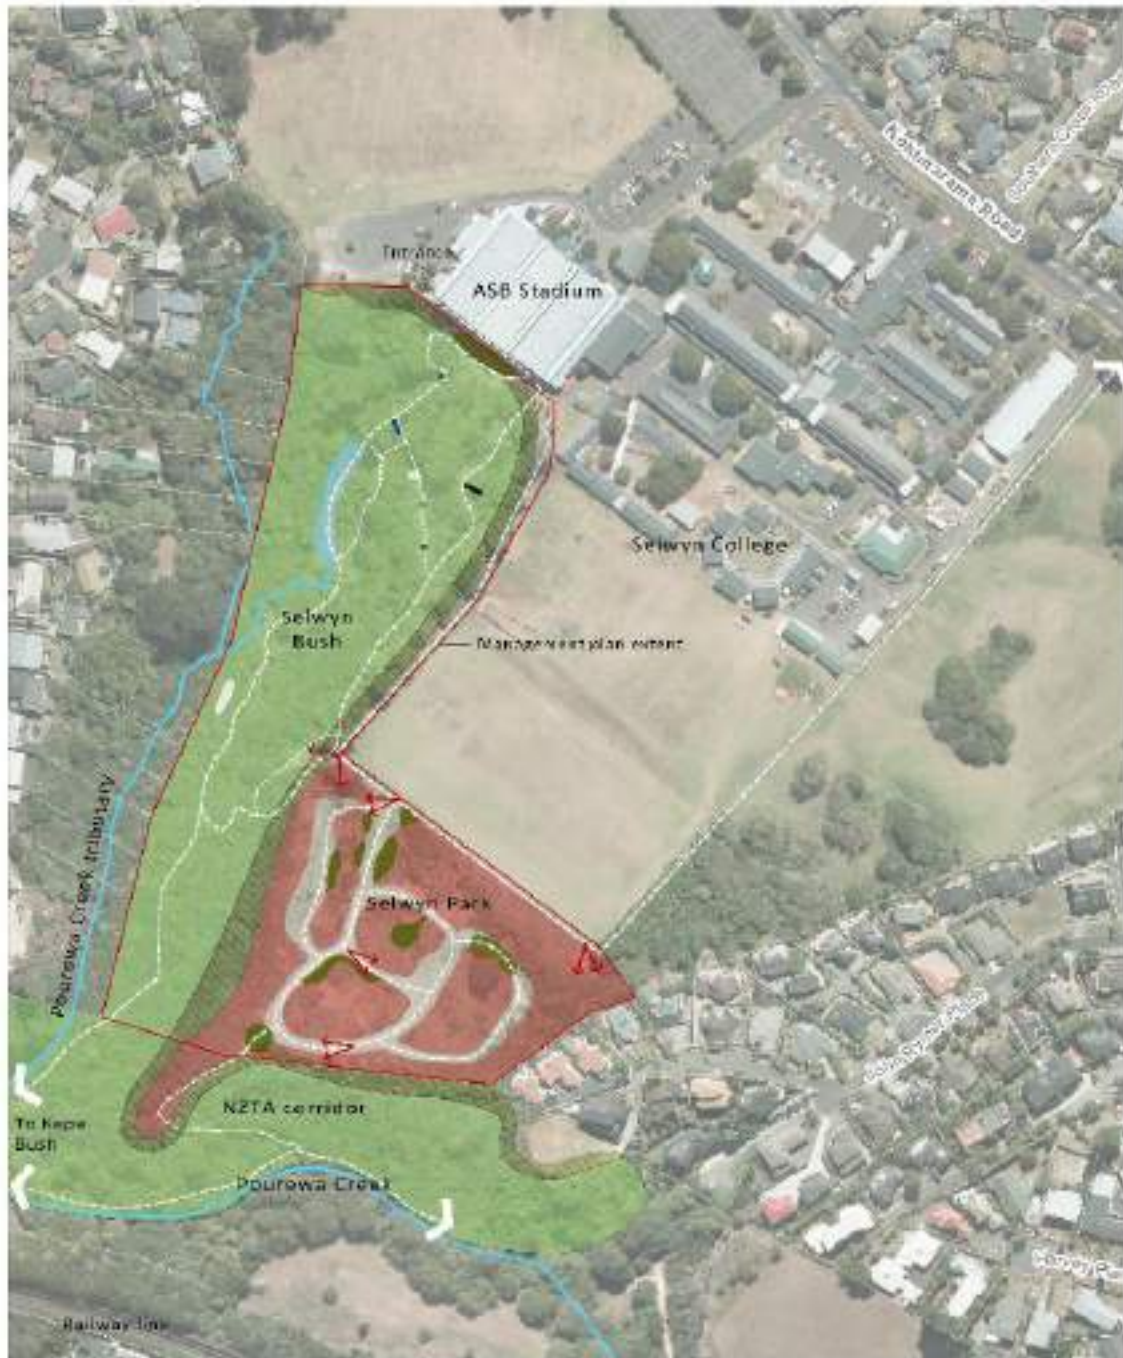
Figure 1 Orientation Map of Selwyn Bush, showing the portion that is an SEA under the District Plan.

For the purpose of this restoration plan, Selwyn Park will be viewed as being very separate from Selwyn Bush. It will not be included in this document except for orientation purposes. The maps in this document illustrate clearly where the boundary lies between these two sites, based on their different provisions and designations under the District Plan. This plan deals principally with Selwyn Bush – the Selwyn College SEA area and the buffer strip to this (Fig 1).

Selwyn Bush runs from the north, below the ASB Stadium, towards Pourewa Creek (refer Figure 1).

Tracks have been created through Selwyn Bush. These can be seen on the Selwyn Bush orientation map (Fig. 1).

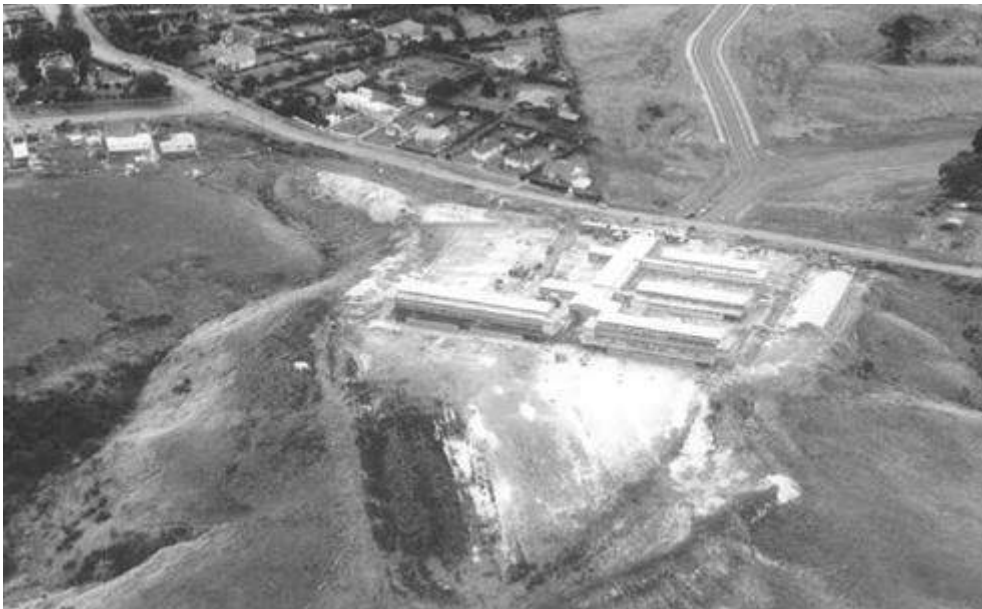
Figure 2 Selwyn College construction (1956)

The former St John’s College Trust Board land was purchased in 1954 by Selwyn College (Graeme Hunt, 2007). The land at this stage was still “rough pasture”. Building work got under way a year or two later. The effects on the landscape are evident in the 1956 photo below.

The ‘50s earthworks were later compounded by the development of the school field and also by the addition of the ASB Stadium (and car park) at the head of Selwyn Bush in the late ‘80’s. This development, along with infill housing and upgrades to Kohimarama Rd, will have significantly changed the hydrology of the Selwyn Bush site and the headwaters of the Pourewa Creek tributary (visible to the left of the College). Remnant native bush can be seen in the Selwyn Bush gully.

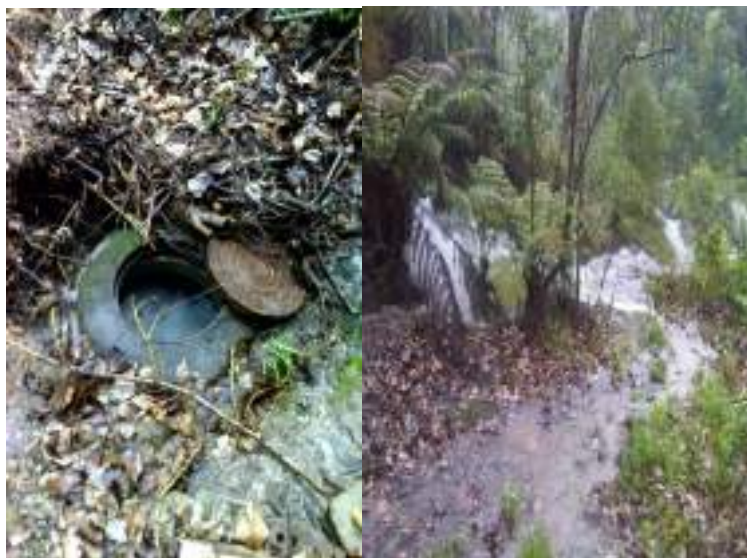
There are stormwater issues at this site that are resulting in erosion, flash flooding, drainage problems and land slippage in places. It is recommended that a stormwater consultant is asked to provide an opinion about the problems and to advise who is responsible if work is required.

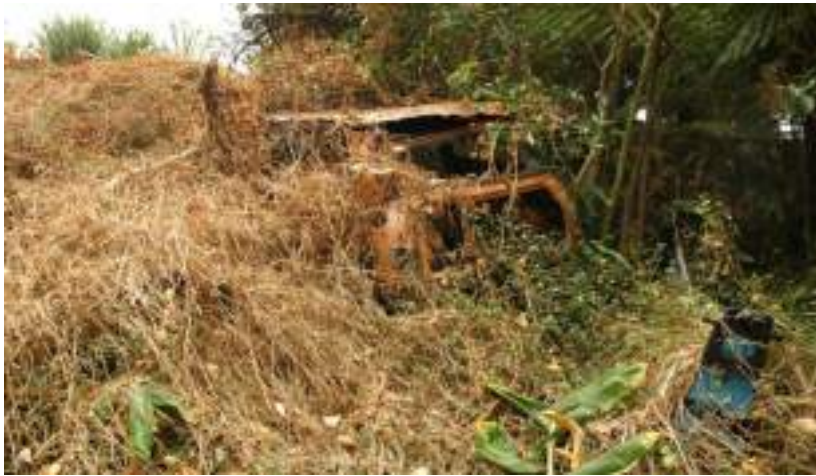
- Past rubbish dumping including “fill”:

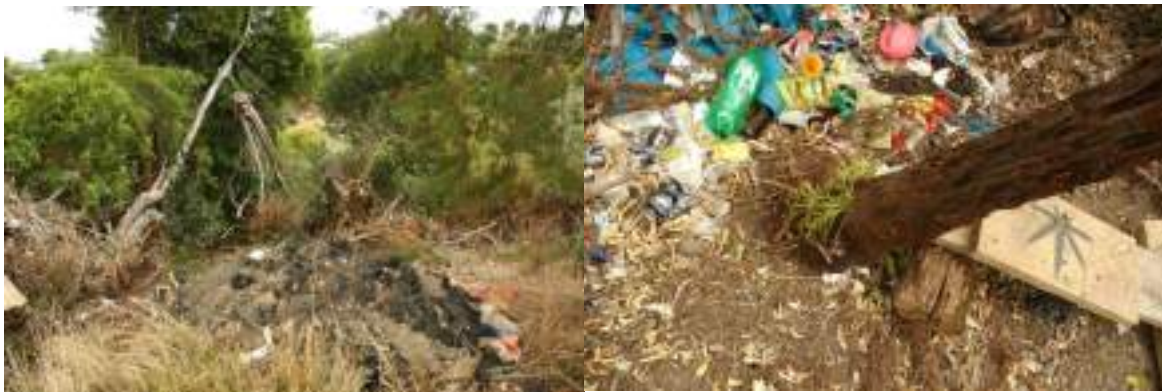
- Current rubbish dumping:

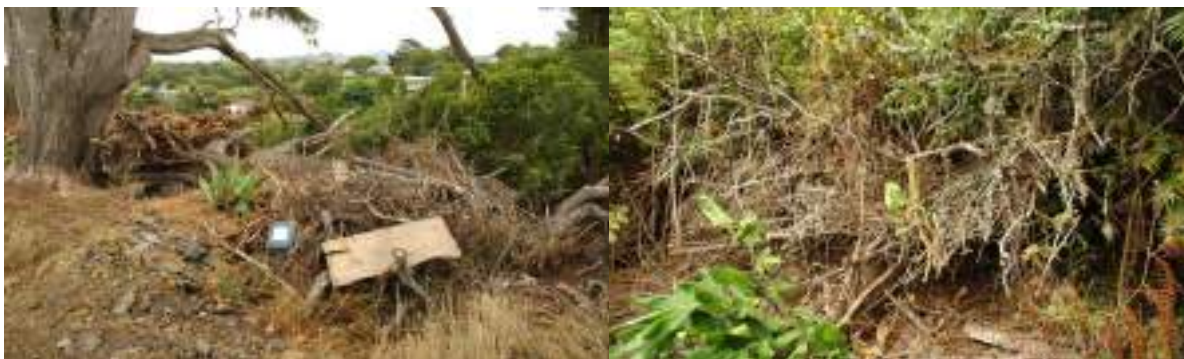
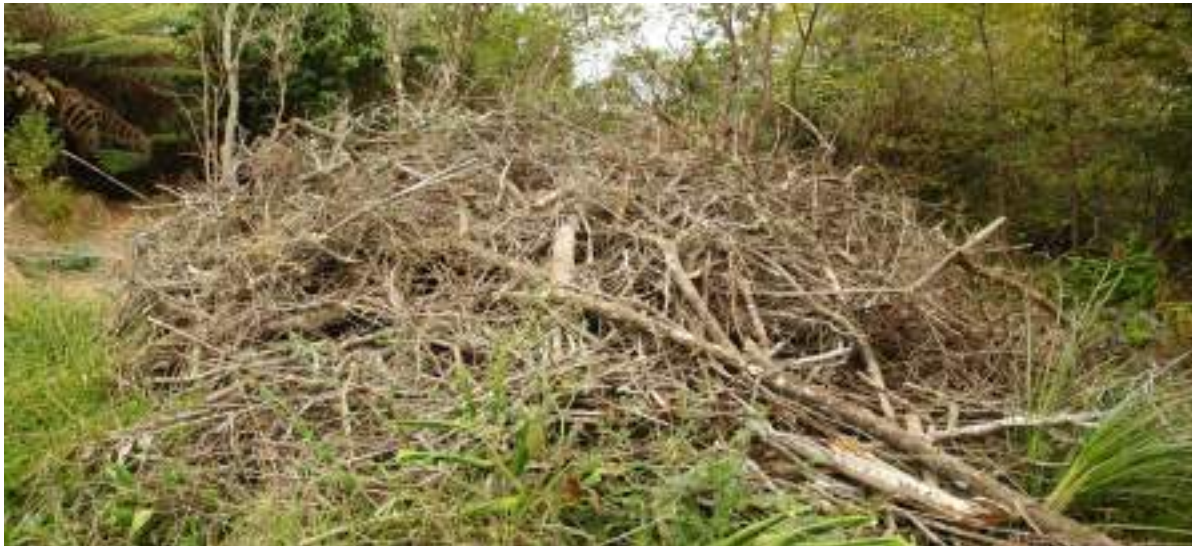
- Accumulated vegetation and woody material as a result of weed control work is in some cases also problematic. Consideration needs to be given to wood piles that present a fire risk, H&S issues, or obstruct restoration work - particularly weed control and planting.

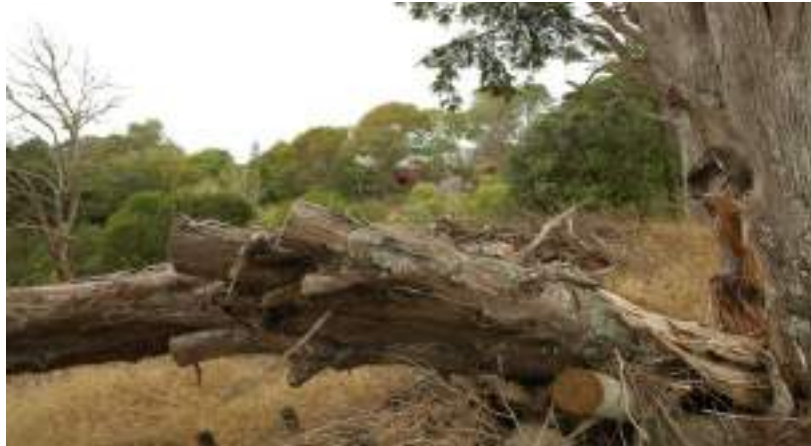
- The use of tools – particularly chainsaws, brushcutters (weed-eaters), mulching machines
- Falling (or felling of) large trees:

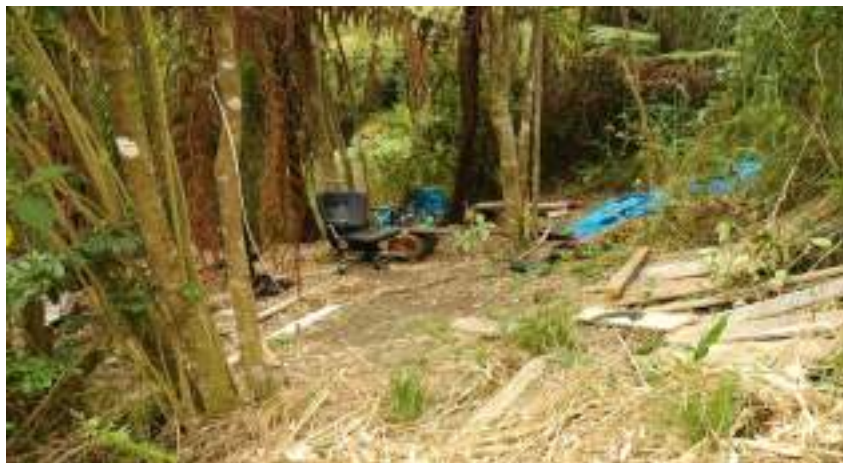
- Rubbish on site (used needles were found on site in an area that has been used by young people as a “hang out” and there is broken glass in this area also):

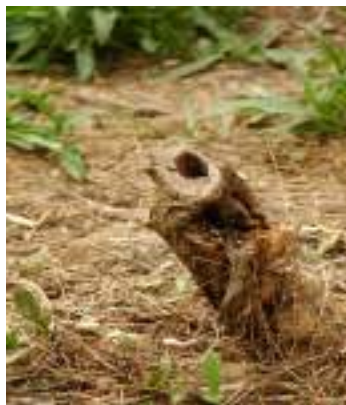
- Steep slopes, poor visibility in some areas where there is dense vegetation – the danger of trips, slips, and eye injuries
- Additional trip hazards – low stumps left above ground or holes left unfilled:

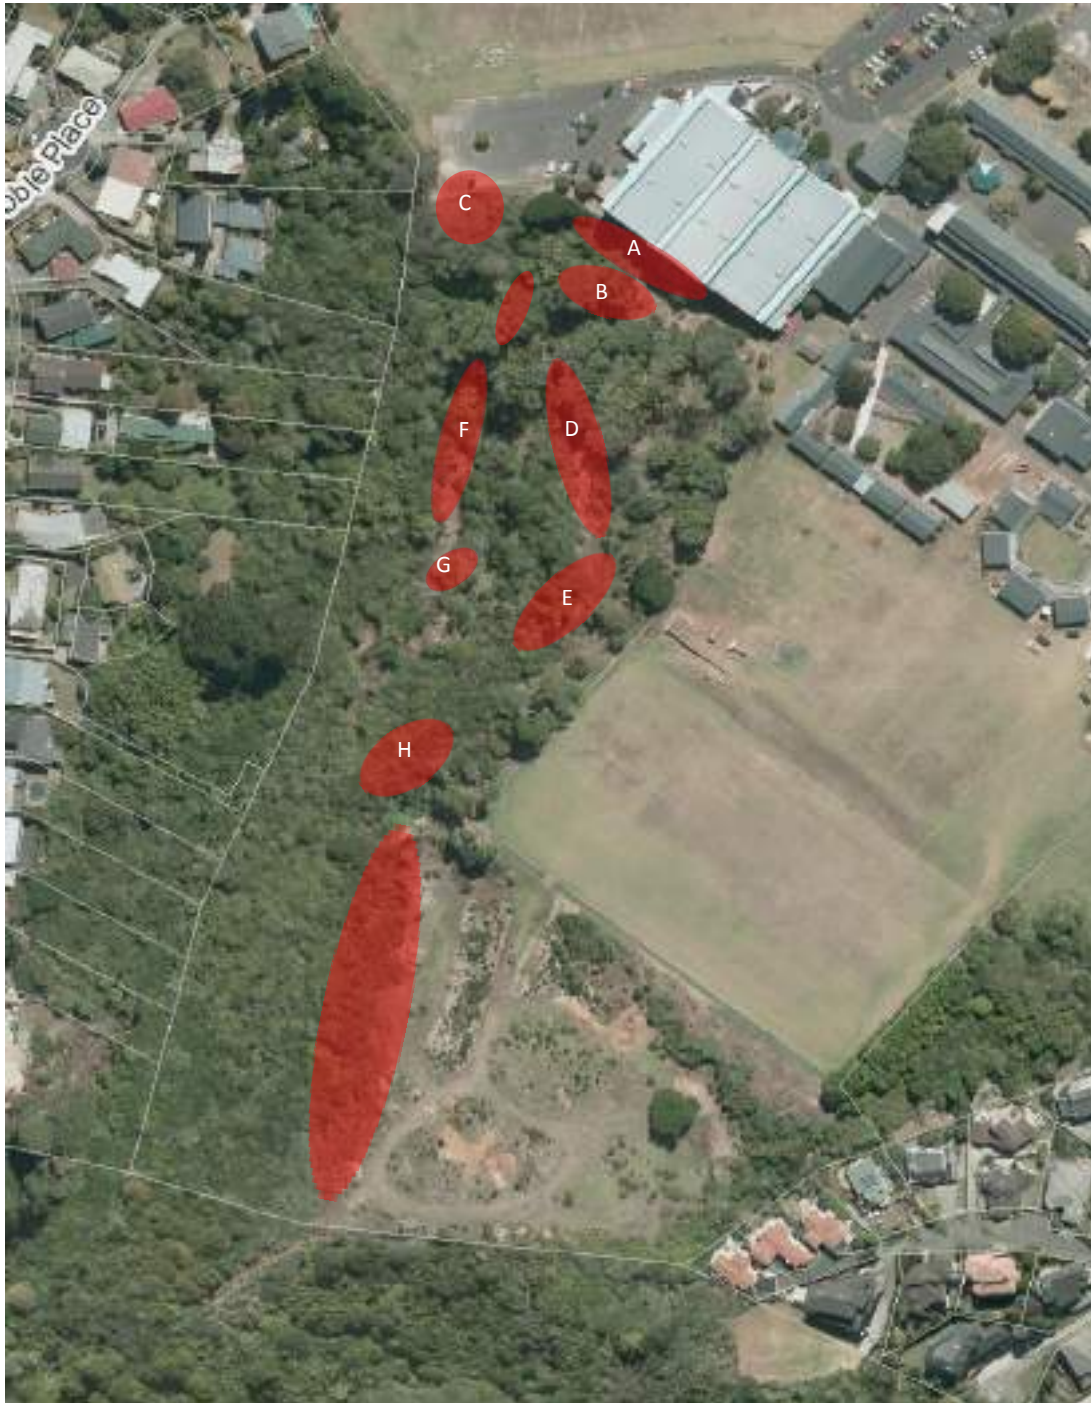
Figure 3: Priority areas for revegetation (Source of GIS basemap: Auckland Council)

Significant areas of the canopy have been opened up in Selwyn Bush mainly through weed clearance but also in track making. These areas are priority spots for revegetation and are marked on the GIS map (Fig. 3). This accompanies photographs of some of these areas in the subsequent pages.

Areas are marked by numbers that relate to the management units they fall within (see the Management Unit Plan map – Appendix E).

pigeonwood, and putaputaweta to create canopy cover. This area is marked by a small red zone (no number) on map (Fig. 3).

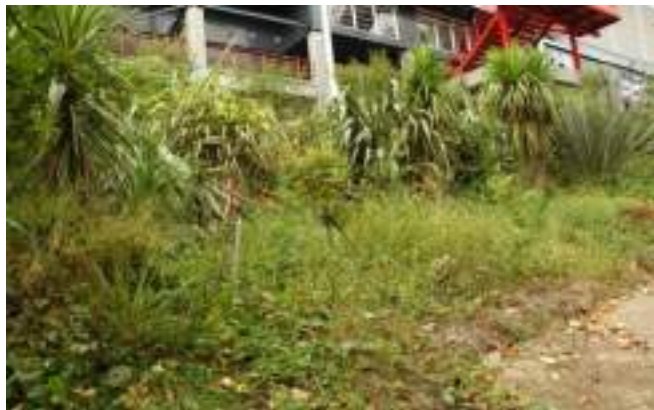
Figure 4: MU 1 – ASB Stadium entrance garden

- a) **Management Unit 1, Planting Area A:** The “entrance garden” behind the ASB stadium. This area has a mixture of native plants, including horticultural varieties. Chemical treatment is recommended for tradescantia and convolvulus. This area needs planting to fill gaps and to provide low canopy cover. This is ideal skink habitat. Harakeke, *Phormium cookianum*, *Astelia banksii*, *Muehlenbeckia complexa*, rengarenga, *Coprosma rhamnoides*, *Corokia cotoneaster* and *Dianella nigra* (in the shadier margins) would make suitable low canopy plants in an area that is principally a native garden. Abundant numbers of juvenile skinks have been observed. These appear to be predominantly the exotic rainbow skink. Copper skink may also be present.

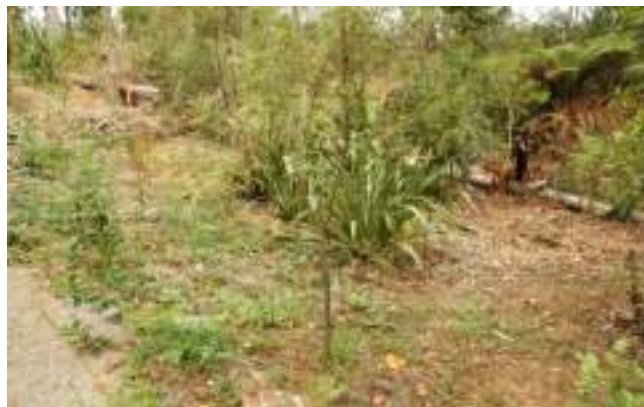
Figure 5: MU 2.

- b) **Management Unit 2, Planting Area B:** This area falls within the SEA. It requires infill planting with species that will provide a good fast canopy, which can be later under-planted. Ponga have been damaged in this area and it makes sense to re-establish these as soon as there is some shelter. Stormwater scouring is evident. A mixture of harekeke and ti kouka would be obvious choices for the scour zones. Karamu, kanuka, manuka, mahoe and mapou would also be good choices throughout this area as pioneer species. Whau may be useful in more sheltered, drier spots. Planted houhere is growing well. Tradescantia, ginger and other weeds require control.

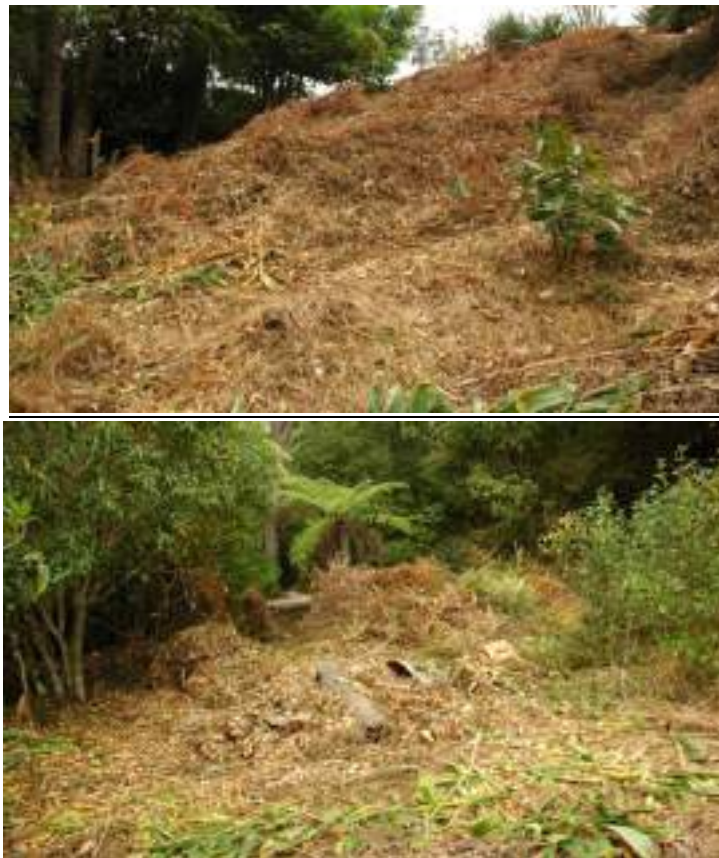
Figure 6: Top of MU 3 (top photo) and the bottom (bottom photo) of the “mini” slope.

- c) **Management Unit 3, Planting Area C:** This area is covered in tradescantia and nasturtium. There is ginger in the lower section that has been cut and treated. This will need follow-up. There is little canopy in this area. This slope has a great deal of dumped rubbish in places and “fill”. Auckland Council advice has been sought and it is felt that this area is best cordoned off, covered with coconut fibre to prevent surface erosion, and planted principally with low vegetation (eg *Muehlenbeckia complexa* and *Phormium cookianum*) where there is little soil. This area has had an initial spray at the top end but will require at least one further treatment before planting. Planting should happen as early as possible in winter. The aim here is to get rapid canopy closure, but still be able to carry out weed control. Some of the poplars on the western ridge should perhaps be taken out or topped before planting and mulched. Suitable initial revegetation species include kanuka, kowhai, mapou, mahoe, karamu, totara, whau, manuka, titoki and puriri; pigeonwood, karaka, and kohekohe in the shadier areas. Mamaku could be added on the bush edge nearer to the bottom of the slope. On the fence margins *Phormium cookianum* would be useful as a buffer edge species. Ti kouka would be good on very steep areas. Kohekohe, kawakawa and karaka are establishing naturally in the bush areas and some seedlings could be transplanted to bush margins. *Gahnia lacera* would be a useful species once weeds are controlled and some light shade has been achieved.

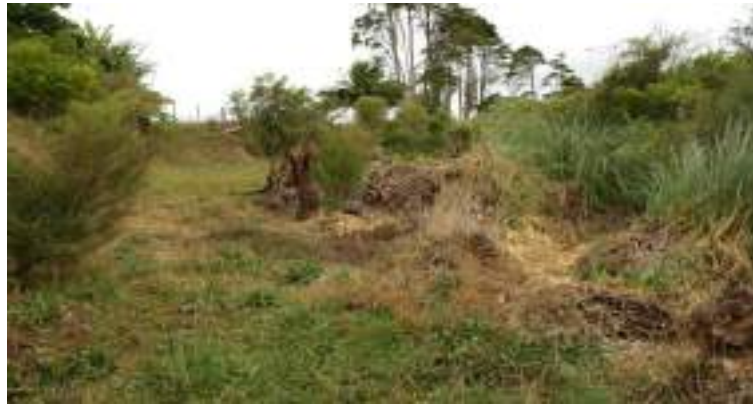
Figure 7: MU 2 & 8 either side of the pipeline track.

- d) **Pipeline Track – Bordering MU 2 & 8, Planting Area D:** There are still areas of live pampas, woody weeds and climbers (eg. jasmine). All gaps could be planted to achieve more shade, greater land stability and to narrow the track. Suitable species include kanuka, karamu, mapou, totara, houpara, houhere, manuka, whau, *Coprosma lucida*, *Coprosma rhamnoides* and kowhai. Karaka and kohekohe could be put into more sheltered areas with some shade. Ti kouka would be good on the slip. It may be prudent to get a stormwater opinion before planting this area, just in case pipe work needs to be done. Clearly the land is unstable.

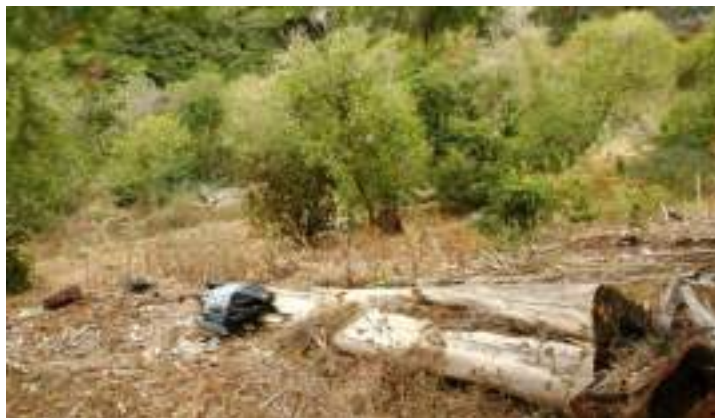
Figure 8: MU 4 – below the phoenix palm.

- e) **Management Unit 4, Planting Area E:** This area (below the phoenix palm) has large gaps. Infill planting would be useful. Some site preparation will be required. Similar species as recommended for the pipeline area could be used. In the short term space should be left around phoenix palm until this has been removed – consent will be required. In the shadier spots lower down the slope taraire could be planted.

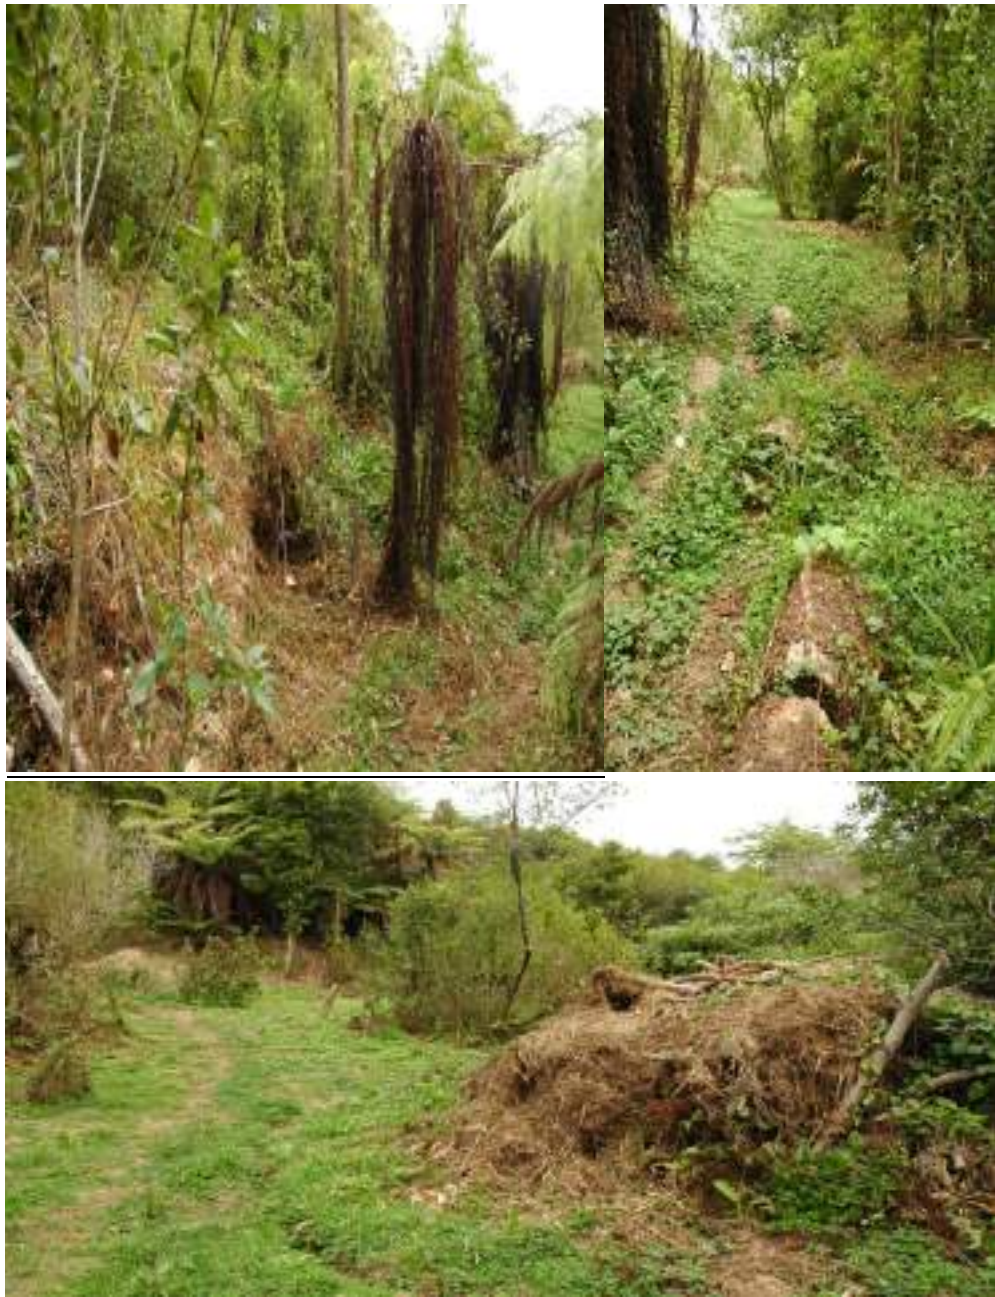
Figure 9: MU 5 - the valley floor and flood zone.

- f) **Management Unit 5, Planting Area F:** This valley floor and its sloping margins would benefit from infill planting. The banks facing west require tough fairly hardy species like houpara, karamu, manuka, mahoe, rewarewa, totara, *Coprosma rhamnoides*, and houhere. In the flood zone kahikatea and mahoe, with nikau, *Gahnia xanthocarpa* and *Carex dissita* (in shady areas nearer the stream once tradescantia has been sprayed and is under control). Ti kouka, harakeke and manuka would be good choices to begin to get some canopy closure in the more open areas.

The valley floor in MU 5 (refer to Appendix E) becomes very water-logged in winter, in part due to stormwater overflow issues. This wetness is ephemeral; the ground is completely dry in summer.

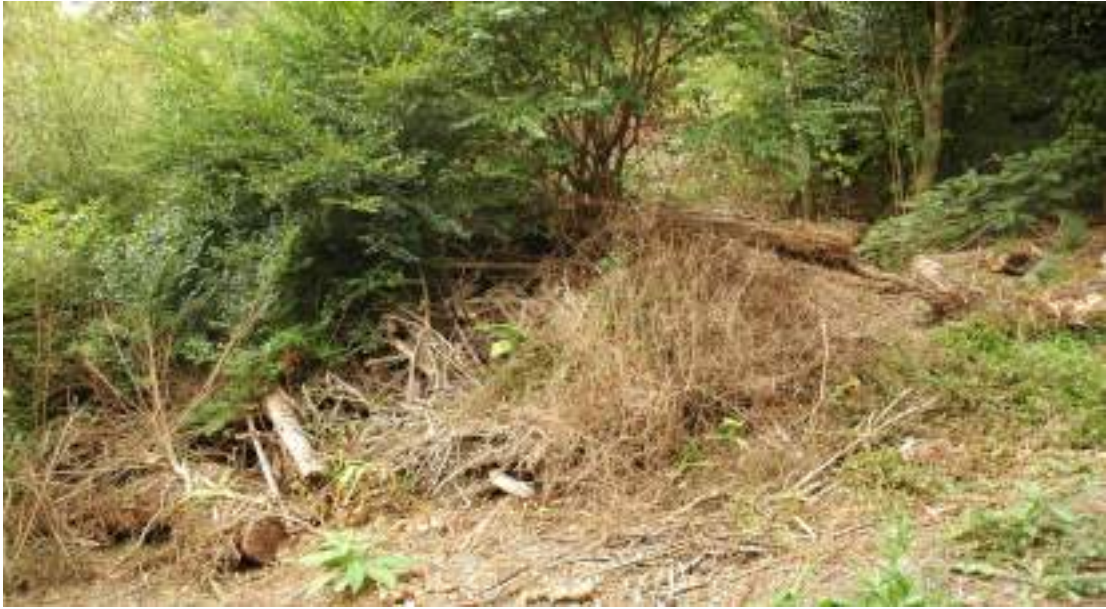
Figure 10 – the MU 5, MU 7, MU 8 intersection

- g) **MU 5, MU 7 and MU 8 intersection, Planting Area G** : This area is open at the meeting of the pathways and would benefit from site prep in terms of weed control of ginger, pampas, convolvulus, Chinese privet saplings etc. Infill planting with pioneer species – ti kouka, whau, mapou, kowhai, houhere, karamu, kanuka, and manuka would be useful.

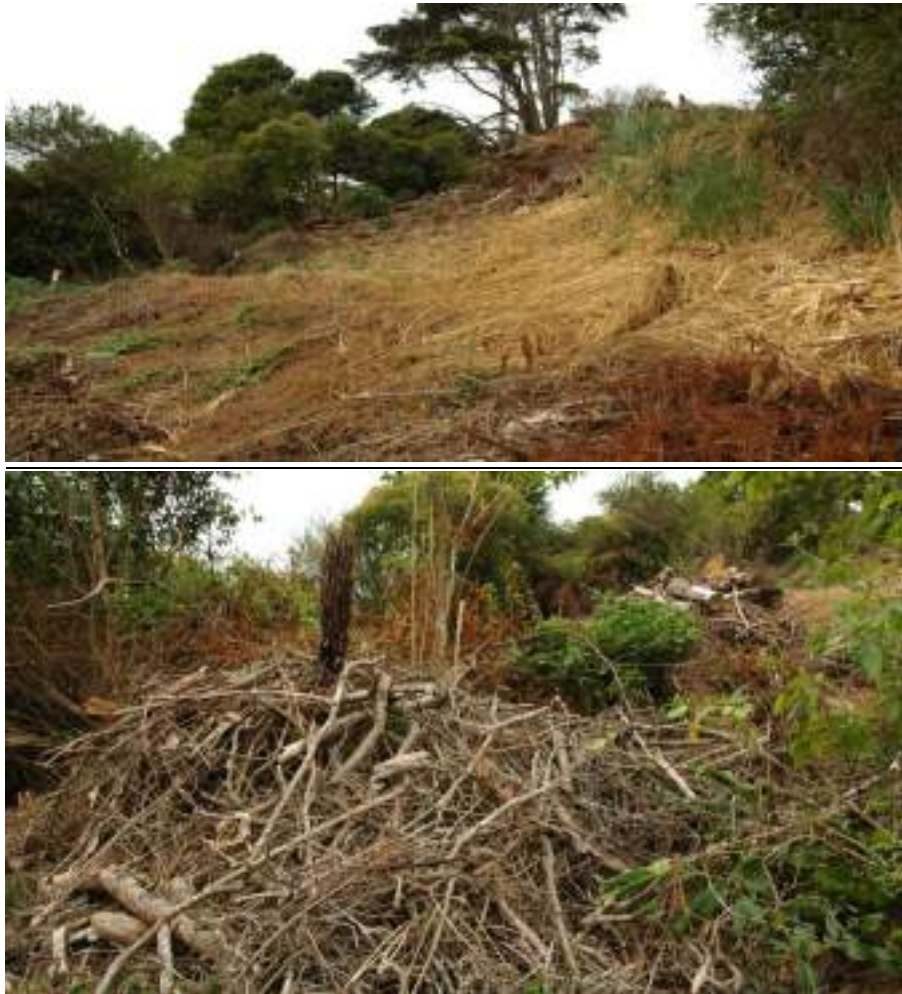
Figure 11: MU 9 “The Junction”

- h) **Management Unit 9, Planting Area H**: This is known as “the junction”. Roy Clements and his refugee volunteer group are responsible for this area. This site has been cleared and there is a considerable amount of wood in this area that would need to be largely removed prior to planting. Mulching this and using it on the slope would help prevent surface erosion and inhibit weeds like Veldt grass. Some native ground ferns have been lost due to loss of shade. Wood is useful habitat and some should be left for this purpose providing it does not interfere with restoration work. Site prep in terms of weed control would need to be done prior to planting. There is a slip zone at the top of the slope, toward the school field fence. Suitable species along the open top edge would be pohutukawa with kowhai further down the slope and *Phormium cookianum* on the steep unstable bank. The view shaft needs to be kept fairly open at the top of the area. Widely spaced pohutukawa and dense-planted *P.cookianum* would achieve this in the buffer strip. The lower area – the floor of MU 9 could have a few lowland broadleaf specimen trees – puriri, titoki, pigeonwood, karaka, taraire, kohekohe (the latter four species are best put in sheltered, shadier spots), with some areas of smaller pioneer trees – mahoe, kanuka, whau, *Coprosma macrocarpa subsp. minor* in more open spots. This area is part of the SEA; horticultural varieties are not appropriate.
